# PROBLEM SUMMARY

Machine Id  
**KAESER 2059539**

Component  
**Compressor**

# OIL ANALYSIS REPORT

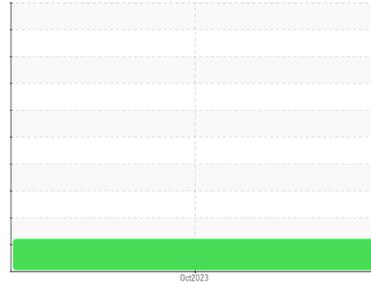
Sample Rating Trend

Sample Status				ATTENTION	---	---
Particles >6µm	ASTM D7647	>1300	▲ 1321	---	---	---
Particles >14µm	ASTM D7647	>80	▲ 85	---	---	---
Oil Cleanliness	ISO 4406 (c)	>--/17/13	▲ 20/18/14	---	---	---

There is a moderate amount of particulates present in the oil.

No corrective action is recommended at this time. The filter change at the time of sampling has been noted. Resample at the next service interval to monitor.

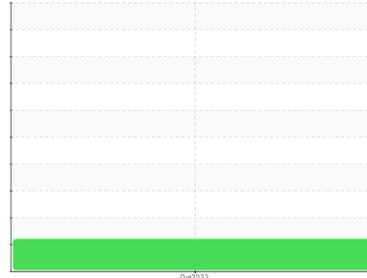
Sample Rating Trend

The AN level is acceptable for this fluid. The condition of the oil is suitable for further service.

No corrective action is recommended at this time. The filter change at the time of sampling has been noted. Resample at the next service interval to monitor.
