Area
PALASYN 45
Machine Id
SULLIVAN PALATEK 22LE003489 - BRINKLEY RV
Component
Compressor

OIL ANALYSIS REPORT

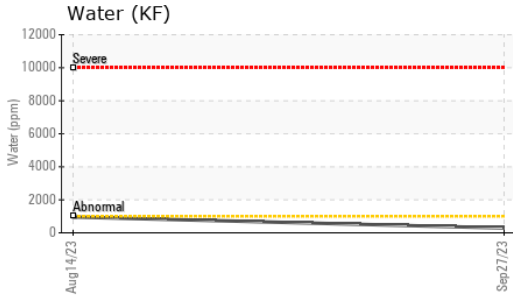
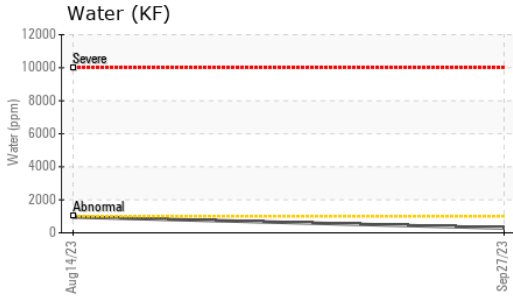
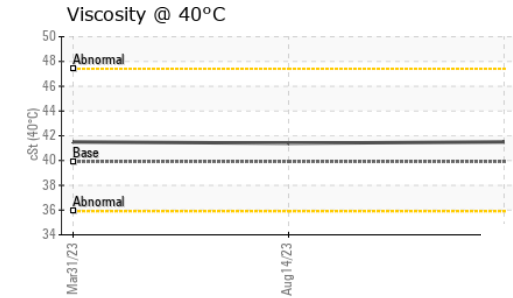
All component wear rates are normal.

There is no indication of any contamination in the oil.

The AN level is acceptable for this fluid. The condition of the oil is suitable for further service.

Resample at the next service interval to monitor.

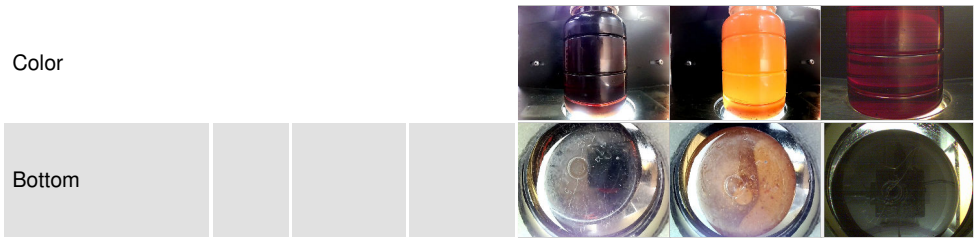
SAMPLE IMAGES	method	limit/base	current	history1	history2
---------------	--------	------------	---------	----------	----------

VISUAL	method	limit/base	current	history1	history2	
White Metal	scalar	*Visual	NONE	NONE	NONE	LIGHT
Yellow Metal	scalar	*Visual	NONE	NONE	NONE	NONE
Precipitate	scalar	*Visual	NONE	NONE	NONE	NONE
Silt	scalar	*Visual	NONE	NONE	NONE	NONE
Debris	scalar	*Visual	NONE	NONE	NONE	LIGHT
Sand/Dirt	scalar	*Visual	NONE	NONE	NONE	NONE
Appearance	scalar	*Visual	NORML	NORML	NORML	NORML
Odor	scalar	*Visual	NORML	NORML	NORML	NORML
Emulsified Water	scalar	*Visual	>0.1	0.2%	0.2%	NEG
Free Water	scalar	*Visual		NEG	NEG	NEG
