# PROBLEM SUMMARY

Area  
**KANSAS/44/EG - OTHER SERVICE**  
 Machine Id  
**57.03W [KANSAS^44^EG - OTHER SERVICE]**  
 Component  
**Right Reduction Gear**  
 Fluid  
**NOT GIVEN (--- GAL)**

# OIL ANALYSIS REPORT

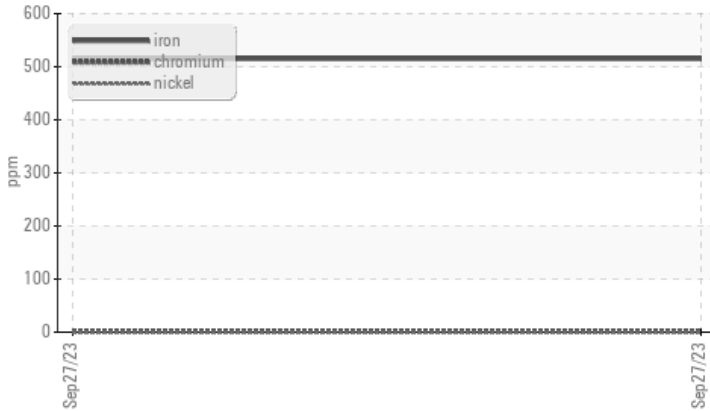
### ▲ Ferrous Alloys

Sample Status				ABNORMAL	---	---
Iron	ppm	ASTM D5185m	>150	▲ 515	---	---

Gear wear is indicated. All other component wear rates are normal.

No corrective action is recommended at this time.  
 Resample at the next service interval to monitor.
