Area
URC
 Machine Id
ROV ELECTRIC COMPENSATOR
 Component
Fluid
 Fluid
TEXACO TRANSFORMER OIL (--- GAL)

OIL ANALYSIS REPORT

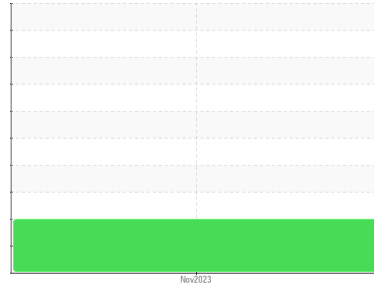
Sample Rating Trend

Sample Status			ABNORMAL	---	---
Particles >4µm	ASTM D7647	>5000	▲ 17357	---	---
Particles >6µm	ASTM D7647	>1300	▲ 4188	---	---
Particles >14µm	ASTM D7647	>160	▲ 267	---	---
Particles >21µm	ASTM D7647	>40	▲ 60	---	---
Oil Cleanliness	ISO 4406 (c)	>19/17/14	▲ 21/19/15	---	---

There is a high amount of particulates present in the fluid.

We recommend you service the filters on this component. Resample at the next service interval to monitor.
