OIL ANALYSIS REPORT

Machine Id
STARLINE SL-5104 3 (S/N 7129)

Component
Hydraulic System

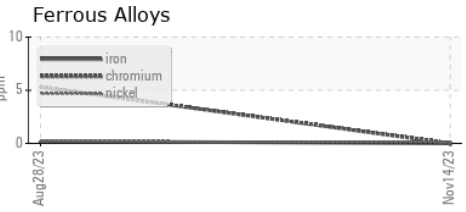
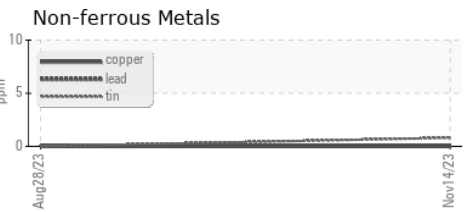
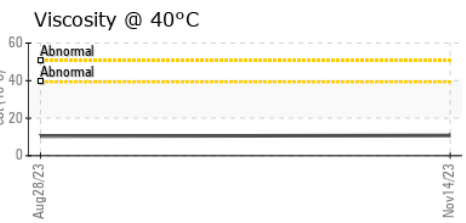
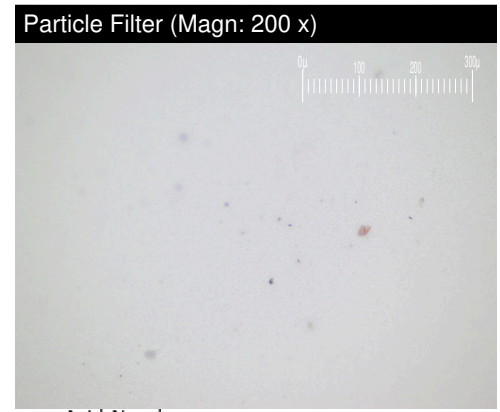
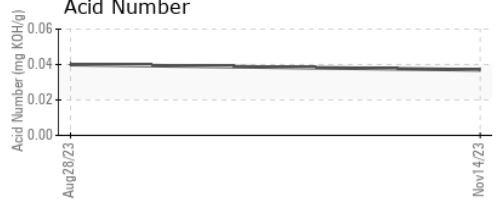
GRAPHS

All component wear rates are normal.

There is no indication of any contamination in the oil. The amount and size of particulates present in the system are acceptable.

The AN level is acceptable for this fluid. The condition of the oil is suitable for further service.

Resample at the next service interval to monitor. Please specify the brand, type, and viscosity of the oil on your next sample.
