Machine Id
3
 Component
Hydraulic System
 Fluid
NOT GIVEN (--- GAL)

Customer Id: MEILEW
Sample No.: KFS06008292
Lab Number: 06008292
Test Package: PLANT

OIL ANALYSIS REPORT

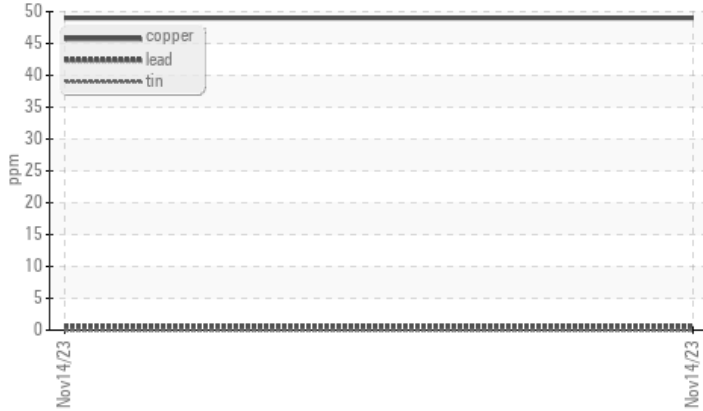
▲ Non-ferrous Metals

Sample Status				ABNORMAL	---	---
Copper	ppm	ASTM D5185m	>20	▲ 49	---	---
Debris	scalar	*Visual	NONE	▲ MODER	---	---

The copper level is abnormal. All other component wear rates are normal.

Moderate concentration of visible dirt/debris present in the oil.

We recommend you service the filters on this component if applicable. Resample at the next service interval to monitor. We were unable to perform a particle count due to a high concentration of particles present in this sample.
