Machine Id
C-2703 WEST (S/N MK6C-693)
 Component
Refrigeration Compressor
 Fluid
FES 4 (240 GAL)

Customer Id: RECSIL_USP
 Sample No.: USP0003724
 Lab Number: 06008356
 Test Package: IND 2

OIL ANALYSIS REPORT

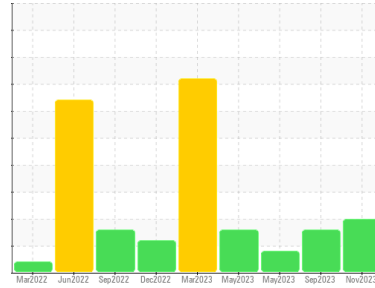
Sample Rating Trend

▲ Particle Trend

Sample Status			ABNORMAL	ABNORMAL	ATTENTION
Particles >4µm	ASTM D7647	>10000	▲ 81857	▲ 34387	▲ 10158
Particles >6µm	ASTM D7647	>2500	▲ 18351	▲ 8401	1844
Particles >14µm	ASTM D7647	>320	▲ 591	▲ 359	37
Particles >21µm	ASTM D7647	>80	▲ 100	60	3
Oil Cleanliness	ISO 4406 (c)	>20/18/15	▲ 24/21/16	▲ 22/20/16	▲ 21/18/12

We recommend you service the filters on this component. Resample at the next service interval to monitor.

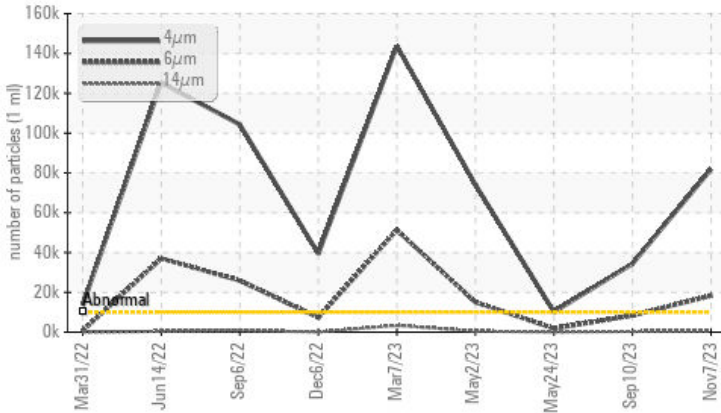
There is a high amount of particulates present in the oil.

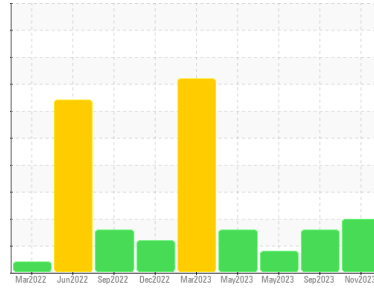
Sample Rating Trend

method	limit/base	current	history1	history2
Particles >4µm	ASTM D7647	>10000	▲ 81857	▲ 34387	▲ 10158
Particles >6µm	ASTM D7647	>2500	▲ 18351	▲ 8401	1844
Particles >14µm	ASTM D7647	>320	▲ 591	▲ 359	37
Particles >21µm	ASTM D7647	>80	▲ 100	60	3
Particles >38µm	ASTM D7647	>20	1	1	0
Particles >71µm	ASTM D7647	>4	0	0	0
Oil Cleanliness	ISO 4406 (c)	>20/18/15	▲ 24/21/16	▲ 22/20/16	▲ 21/18/12

We recommend you service the filters on this component. Resample at the next service interval to monitor.

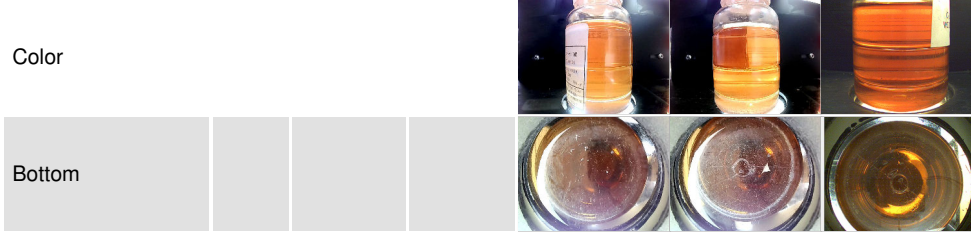
SAMPLE IMAGES	method	limit/base	current	history1	history2
---------------	--------	------------	---------	----------	----------

VISUAL	method	limit/base	current	history1	history2
White Metal	scalar	*Visual	NONE	NONE	LIGHT
Yellow Metal	scalar	*Visual	NONE	NONE	NONE
Precipitate	scalar	*Visual	NONE	NONE	NONE
Silt	scalar	*Visual	NONE	NONE	NONE
Debris	scalar	*Visual	NONE	NONE	LIGHT
Sand/Dirt	scalar	*Visual	NONE	NONE	NONE
Appearance	scalar	*Visual	NORML	NORML	NORML
Odor	scalar	*Visual	NORML	NORML	NORML
Emulsified Water	scalar	*Visual	>0.01	NEG	NEG
Free Water	scalar	*Visual		NEG	NEG
