OIL ANALYSIS REPORT

Area
COLORADO/443/EG - LOADER
 Machine Id
46.100L [COLORADO^443^EG - LOADER]
 Component
Hydraulic System
 Fluid
MOBIL MOBILTRANS AST 30 (30 GAL)

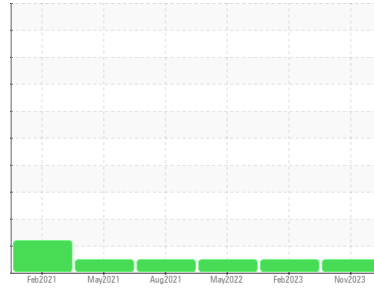
Sample Rating Trend

NORMAL

All component wear rates are normal.

The amount and size of particulates present in the system are acceptable. There is no indication of any contamination in the oil.

The AN level is acceptable for this fluid. The condition of the oil is suitable for further service.

Resample at the next service interval to monitor.
