Area
TULSA [18327]
 Machine Id
Cat D6N
 Component
Left Final Drive
 Fluid
CONOCO PHILLIPS GUARDOL ECT 15W40 (--- GAL)

Customer Id: MANTUL
 Sample No.: WC0818781
 Lab Number: 06010407
 Test Package: CONST

OIL ANALYSIS REPORT

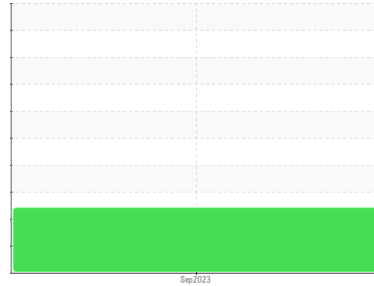
Sample Rating Trend

Sample Status	ABNORMAL		---	---
Aluminum	ppm	ASTM D5185m >75	▲ 23	---
Silicon	ppm	ASTM D5185m >400	▲ 237	---

Elemental levels of silicon (Si) and aluminum (Al) indicate alumina-silicate (coarse dirt) ingress.

We advise that you check all areas where dirt can enter the system. The oil change at the time of sampling has been noted. Resample at the next service interval to monitor.

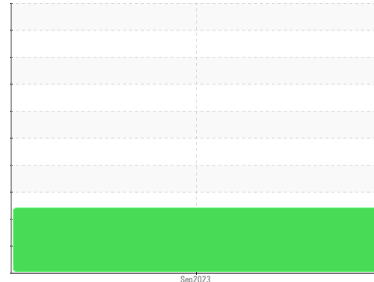
Sample Rating Trend

DIRT

We advise that you check all areas where dirt can enter the system. The oil change at the time of sampling has been noted. Resample at the next service interval to monitor.

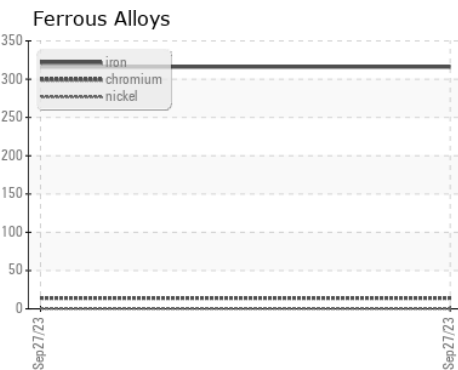
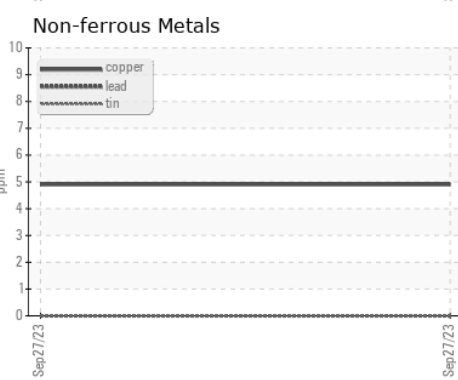
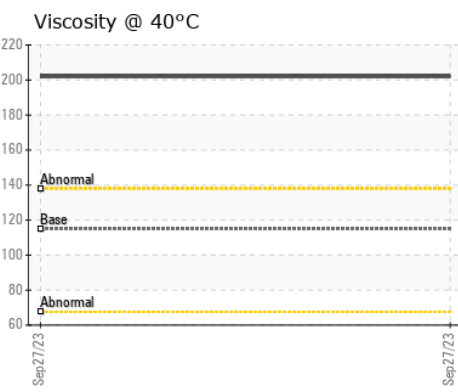
GRAPHS

method	limit/base	current	history1	history2
Iron	ppm	ASTM D5185m >800	316	---	---
Chromium	ppm	ASTM D5185m >10	14	---	---
Nickel	ppm	ASTM D5185m >5	<1	---	---
Titanium	ppm	ASTM D5185m >15	3	---	---
Silver	ppm	ASTM D5185m >2	0	---	---
Aluminum	ppm	ASTM D5185m >75	▲ 23	---	---
Lead	ppm	ASTM D5185m >10	0	---	---
Copper	ppm	ASTM D5185m >75	5	---	---
Tin	ppm	ASTM D5185m >8	0	---	---
Vanadium	ppm	ASTM D5185m	1	---	---
Cadmium	ppm	ASTM D5185m	0	---	---

method	limit/base	current	history1	history2
Silicon	ppm	ASTM D5185m >400	▲ 237	---	---
Sodium	ppm	ASTM D5185m	13	---	---
Potassium	ppm	ASTM D5185m >20	27	---	---
