Customer Id: GFLNEW  
Sample No.: KC06010792  
Lab Number: 06010792  
Test Package: IND 2

# OIL ANALYSIS REPORT

Machine Id  
**7913996 (S/N 1087)**  
 Component  
**Compressor**  
 Fluid  
**KAESER SIGMA (OEM) S-460 (--- GAL)**

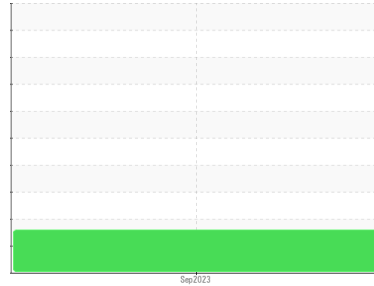
Sample Rating Trend

### ▲ Particle Trend

Sample Status			<b>ABNORMAL</b>	---	---
Particles >6µm	ASTM D7647	>1300	▲ <b>2800</b>	---	---
Particles >14µm	ASTM D7647	>80	▲ <b>246</b>	---	---
Particles >21µm	ASTM D7647	>20	▲ <b>70</b>	---	---
Oil Cleanliness	ISO 4406 (c)	>--/17/13	▲ <b>20/19/15</b>	---	---

There is a high amount of particulates present in the oil.

No corrective action is recommended at this time. The filter change at the time of sampling has been noted. Resample at the next service interval to monitor.

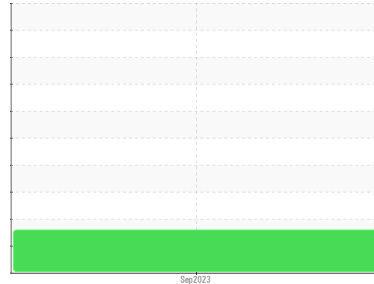
Sample Rating Trend

All component wear rates are normal.

The AN level is acceptable for this fluid. The condition of the oil is suitable for further service.

No corrective action is recommended at this time. The filter change at the time of sampling has been noted. Resample at the next service interval to monitor.
