Machine Id  
**8026025 (S/N 1184)**

Component  
**Compressor**

Fluid  
**KAESER SIGMA (OEM) S-460 (--- GAL)**

# OIL ANALYSIS REPORT

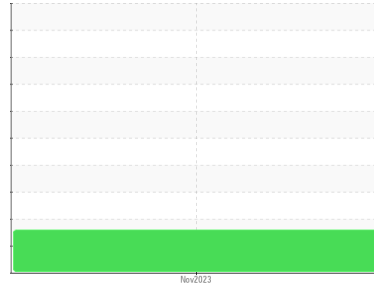
Sample Rating Trend

There is a high amount of particulates present in the oil.

No corrective action is recommended at this time. The filter change at the time of sampling has been noted. Resample at the next service interval to monitor.
