Customer Id: ADTCAN
Sample No.: KCPA005263
Lab Number: 06010851
Test Package: IND 2

OIL ANALYSIS REPORT

Machine Id
KAESER NOT GIVEN KCPA005263 (S/N NO INFO GIVEN)
 Component
Compressor
 Fluid
KAESER SIGMA (OEM) S-460 (--- GAL)

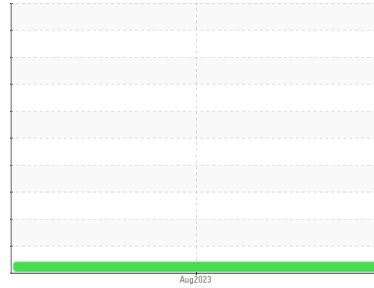
Sample Rating Trend

VIS DEBRIS

Sample Status				ABNORMAL	---	---
Debris	scalar	*Visual	NONE	▲ MODER	---	---

No corrective action is recommended at this time. The filter change at the time of sampling has been noted. Resample at the next service interval to monitor. We were unable to perform a particle count due to a high concentration of particles present in this sample.

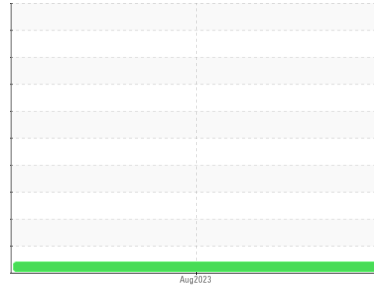
Sample Rating Trend

VIS DEBRIS

Moderate concentration of visible dirt/debris present in the oil.

No corrective action is recommended at this time. The filter change at the time of sampling has been noted. Resample at the next service interval to monitor. We were unable to perform a particle count due to a high concentration of particles present in this sample.

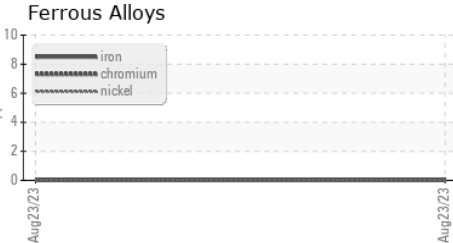
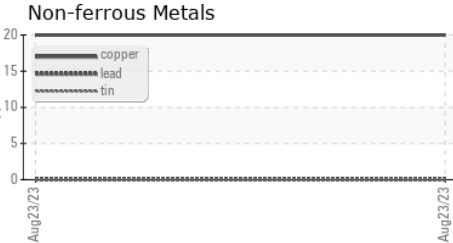
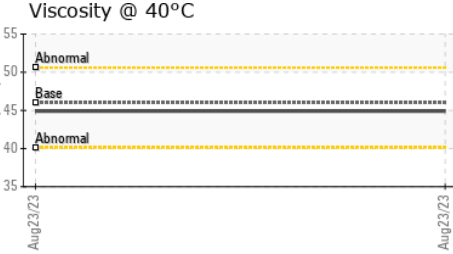
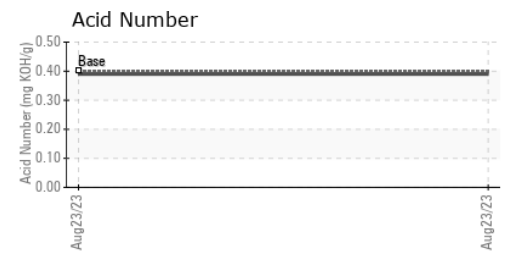
GRAPHS

All component wear rates are normal.

The AN level is acceptable for this fluid. The condition of the oil is suitable for further service.
