OIL ANALYSIS REPORT

Machine Id
F00512 - HSC 2-5 (S/N 3383)

Component
Refrigeration Compressor

Fluid
VILTER 717 COMPRESSOR OIL ISO 68 (--- GAL)

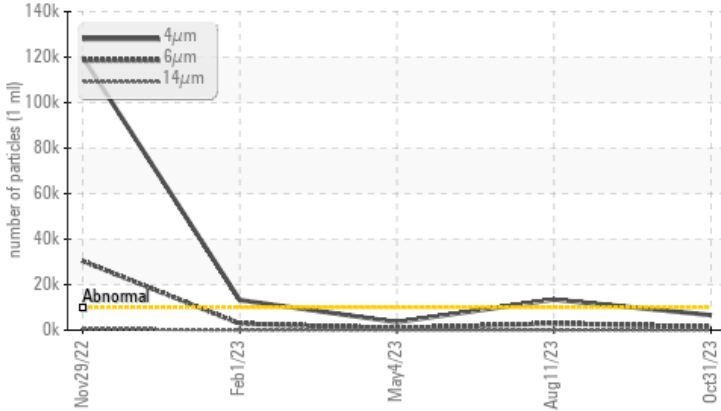
▲ Particle Trend

Sample Status		ATTENTION	ABNORMAL	NORMAL
Particles >6µm	ASTM D7647 >1300	▲ 1484	▲ 2975	888
Oil Cleanliness	ISO 4406 (c) >20/17/14	▲ 20/18/11	▲ 21/19/13	19/17/12

No corrective action is recommended at this time.
 Resample at the next service interval to monitor.

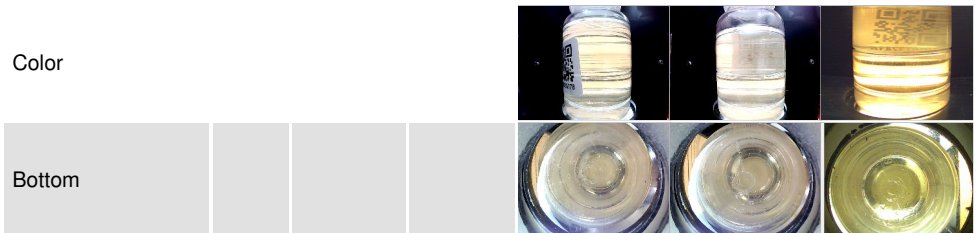
SAMPLE IMAGES	method	limit/base	current	history1	history2
---------------	--------	------------	---------	----------	----------

VISUAL	method	limit/base	current	history1	history2
White Metal	scalar	*Visual	NONE	NONE	NONE
Yellow Metal	scalar	*Visual	NONE	NONE	NONE
Precipitate	scalar	*Visual	NONE	NONE	NONE
Silt	scalar	*Visual	NONE	NONE	NONE
Debris	scalar	*Visual	NONE	NONE	NONE
Sand/Dirt	scalar	*Visual	NONE	NONE	NONE
Appearance	scalar	*Visual	NORML	NORML	NORML
Odor	scalar	*Visual	NORML	NORML	NORML
Emulsified Water	scalar	*Visual	>0.01	NEG	NEG
Free Water	scalar	*Visual		NEG	NEG
