OIL ANALYSIS REPORT

Machine Id
ALSTOM R084 - PC2022

Component
Rear Left Gearbox

Fluid
TOTAL CARTER SH 220 (3 GAL)

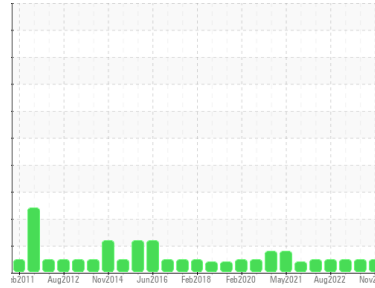
Sample Rating Trend

NORMAL

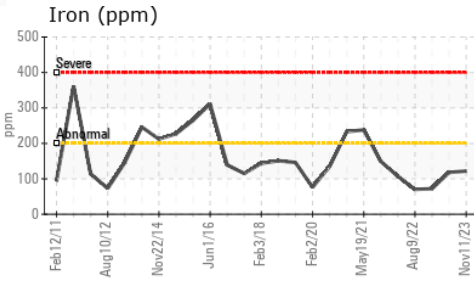
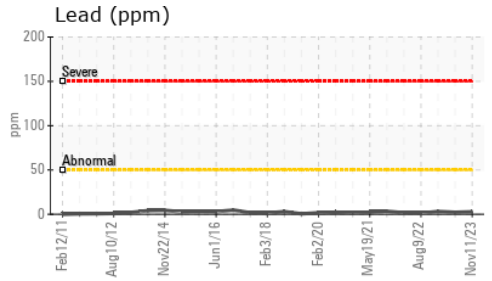
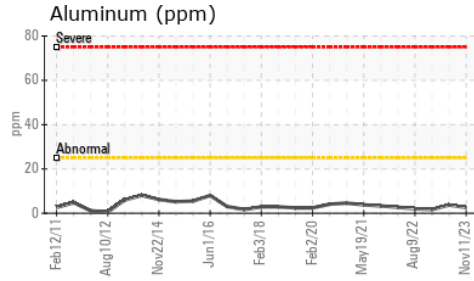
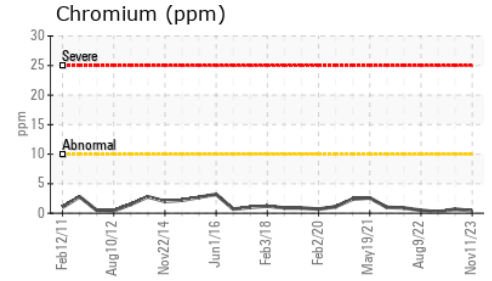
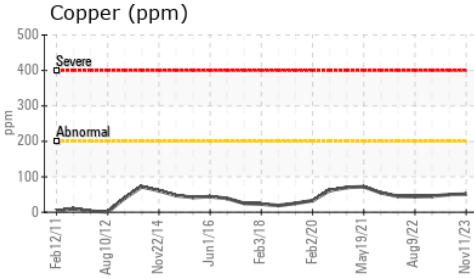
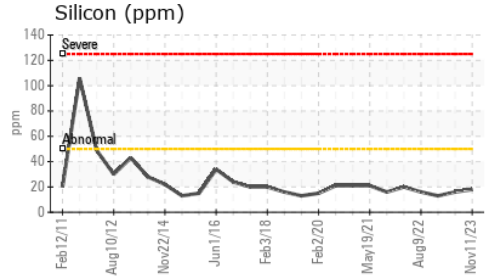
GRAPHS

All component wear rates are normal.

There is no indication of any contamination in the oil.

The AN level is acceptable for this fluid. The condition of the oil is suitable for further service.

Resample at the next service interval to monitor.
