OIL ANALYSIS REPORT

Machine Id
ALSTOM R046
 Component
Gearbox
 Fluid
TOTAL CARTER SH 220 (3 GAL)

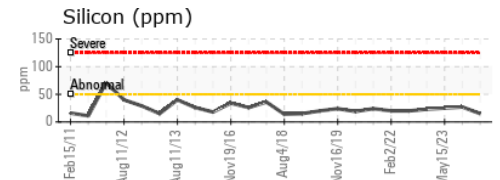
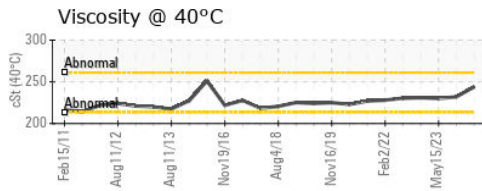
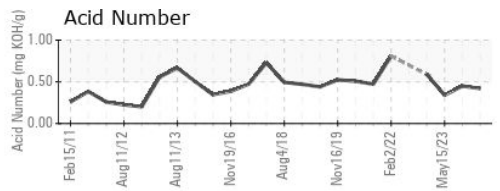
GRAPHS

All component wear rates are normal.

There is no indication of any contamination in the oil.

The AN level is acceptable for this fluid. The condition of the oil is suitable for further service.

Resample at the next service interval to monitor.
