# PROBLEM SUMMARY

Area  
**3 STORK PACK**  
 Machine Id  
**B21613 - 5 (S/N 69700020)**  
 Component  
**Gearbox**  
 Fluid  
**JAX MAGNA-PLATE 85W140-FG (6 GAL)**

# OIL ANALYSIS REPORT

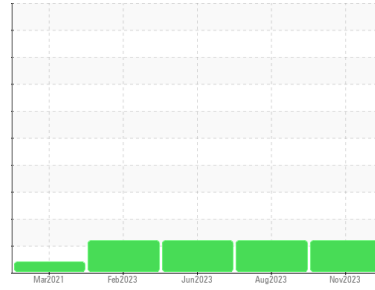
## Sample Rating Trend

Sample Status		ABNORMAL	ABNORMAL	ABNORMAL
Particles >4µm	ASTM D7647 >20000	▲ 84527	▲ 62261	▲ 60598
Particles >6µm	ASTM D7647 >5000	▲ 6064	▲ 5935	▲ 8559
Oil Cleanliness	ISO 4406 (c) >21/19/16	▲ 24/20/14	▲ 23/20/14	▲ 23/20/16

No corrective action is recommended at this time.  
 Resample at the next service interval to monitor.

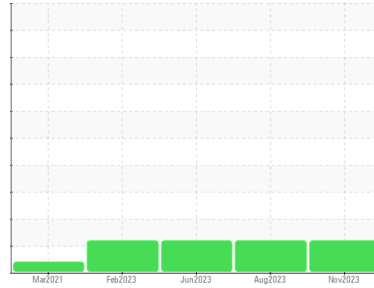
Sample Rating Trend

All component wear rates are normal.

There is a high amount of silt (particulates < 14 microns in size) present in the oil.

The AN level is acceptable for this fluid. The condition of the oil is suitable for further service.

No corrective action is recommended at this time. Resample at the next service interval to monitor.

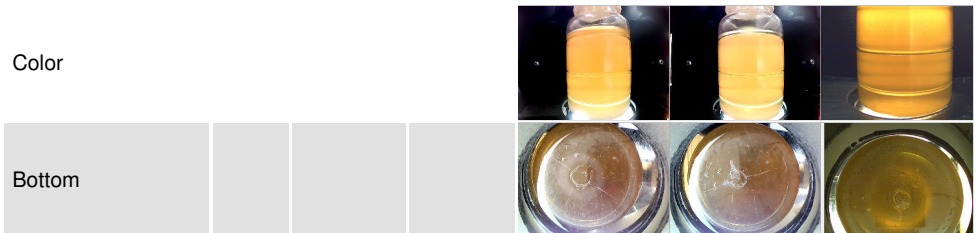
SAMPLE IMAGES	method	limit/base	current	history1	history2
---------------	--------	------------	---------	----------	----------

VISUAL	method	limit/base	current	history1	history2
White Metal	scalar	*Visual	NONE	NONE	NONE
Yellow Metal	scalar	*Visual	NONE	NONE	NONE
Precipitate	scalar	*Visual	NONE	NONE	NONE
Silt	scalar	*Visual	NONE	NONE	LIGHT
Debris	scalar	*Visual	NONE	NONE	NONE
Sand/Dirt	scalar	*Visual	NONE	NONE	NONE
Appearance	scalar	*Visual	NORML	NORML	NORML
Odor	scalar	*Visual	NORML	NORML	NORML
Emulsified Water	scalar	*Visual	>0.2	NEG	NEG
Free Water	scalar	*Visual		NEG	NEG
