Machine Id
8718708 (S/N 1425)

Component
Compressor
Fluid
KAESER SIGMA (OEM) M-460 (--- GAL)

OIL ANALYSIS REPORT

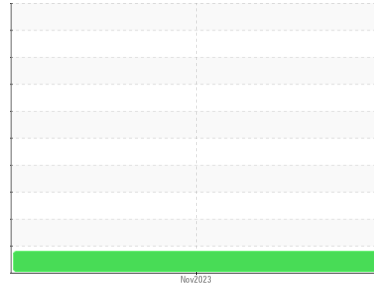
Sample Rating Trend

SEDIMENT

Sample Status				ABNORMAL	---	---
Silt	scalar	*Visual	NONE	▲ MODER	---	---

No corrective action is recommended at this time. The filter change at the time of sampling has been noted. Resample at the next service interval to monitor. We were unable to perform a particle count due to a high concentration of particles present in this sample.

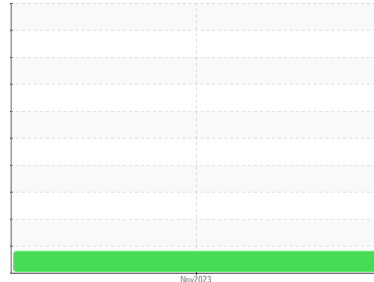
Sample Rating Trend

SEDIMENT

Moderate concentration of visible dirt/debris present in the oil.

No corrective action is recommended at this time. The filter change at the time of sampling has been noted. Resample at the next service interval to monitor. We were unable to perform a particle count due to a high concentration of particles present in this sample.
