OIL ANALYSIS REPORT

Machine Id
ENDEAVOR
 Component
Port Reduction Gear
 Fluid
SHELL ROTELLA T 30 (--- QTS)

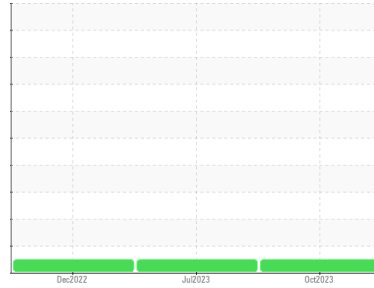
Sample Rating Trend

NORMAL

All component wear rates are normal.

There is no indication of any contamination in the oil.

The AN level is acceptable for this fluid. The condition of the oil is suitable for further service.

Resample at the next service interval to monitor.

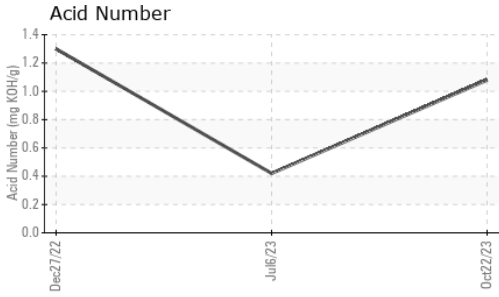
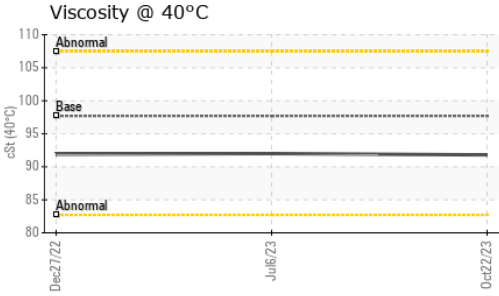
VISUAL	method	limit/base	current	history1	history2
White Metal	scalar	*Visual	NONE	NONE	NONE
Yellow Metal	scalar	*Visual	NONE	NONE	NONE
Precipitate	scalar	*Visual	NONE	NONE	NONE
Silt	scalar	*Visual	NONE	NONE	NONE
Debris	scalar	*Visual	NONE	NONE	NONE
Sand/Dirt	scalar	*Visual	NONE	NONE	NONE
Appearance	scalar	*Visual	NORML	NORML	NORML
Odor	scalar	*Visual	NORML	NORML	NORML
Emulsified Water	scalar	*Visual	>0.1	NEG	NEG
Free Water	scalar	*Visual		NEG	NEG

FLUID PROPERTIES	method	limit/base	current	history1	history2	
Visc @ 40°C	cSt	ASTM D445	97.7	91.8	92.0	91.9
