# PROBLEM SUMMARY

Area  
**PATTONS 4010-5**  
Machine Id  
**ELGI MSG1061260 - PLASTEK GROUP**  
Component  
**Compressor**

# OIL ANALYSIS REPORT

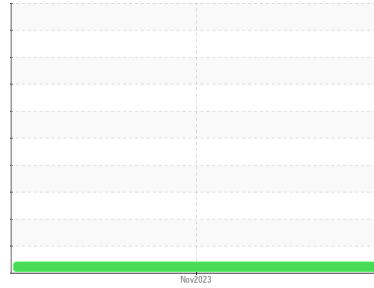
Sample Rating Trend

▲ Viscosity @ 40°C

Sample Status				ATTENTION	---	---
Visc @ 40°C	cSt	ASTM D445	41.57	▲ 71.52	---	---

The oil viscosity is higher than normal. Confirm oil type. The AN level is acceptable for this fluid.

No corrective action is recommended at this time.  
Resample at the next service interval to monitor.

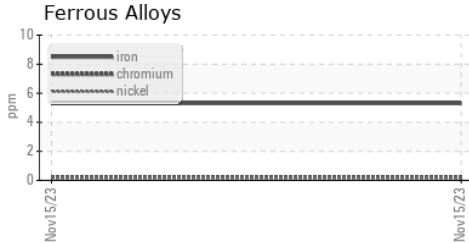
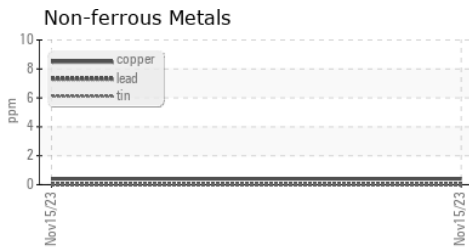
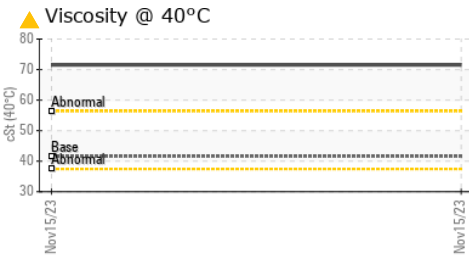
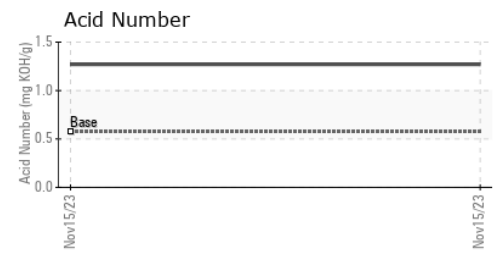
### GRAPHS

FLUID PROPERTIES	method	limit/base	current	history1	history2	
Visc @ 40°C	cSt	ASTM D445	41.57	▲ 71.52	---	---

No corrective action is recommended at this time. Resample at the next service interval to monitor.
