OIL ANALYSIS REPORT

Machine Id
95166J

Component
Compressor

Fluid
INGERSOLL-RAND SSR ULTRA COOLANT (35 GAL)

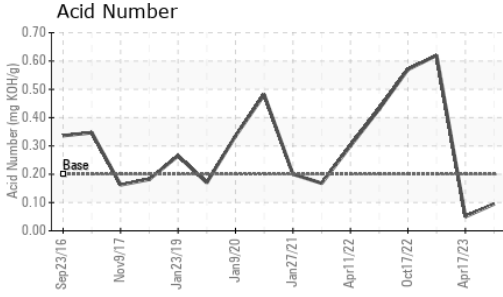
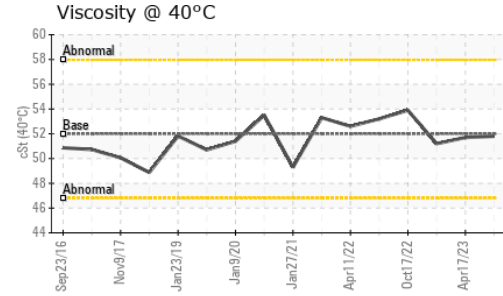
SAMPLE IMAGES	method	limit/base	current	history1	history2
---------------	--------	------------	---------	----------	----------

VISUAL	method	limit/base	current	history1	history2	
White Metal	scalar	*Visual	NONE	NONE	LIGHT	LIGHT
Yellow Metal	scalar	*Visual	NONE	NONE	NONE	NONE
Precipitate	scalar	*Visual	NONE	NONE	NONE	NONE
Silt	scalar	*Visual	NONE	NONE	NONE	NONE
Debris	scalar	*Visual	NONE	NONE	NONE	NONE
Sand/Dirt	scalar	*Visual	NONE	NONE	NONE	NONE
Appearance	scalar	*Visual	NORML	NORML	NORML	NORML
Odor	scalar	*Visual	NORML	NORML	NORML	NORML
Emulsified Water	scalar	*Visual	>0.1	NEG	NEG	NEG
Free Water	scalar	*Visual		NEG	NEG	NEG

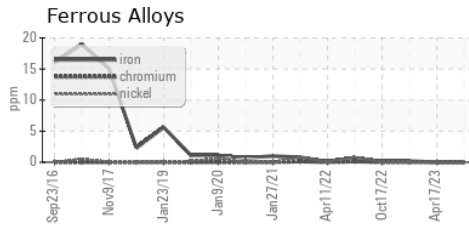
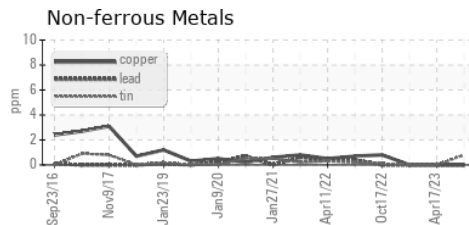
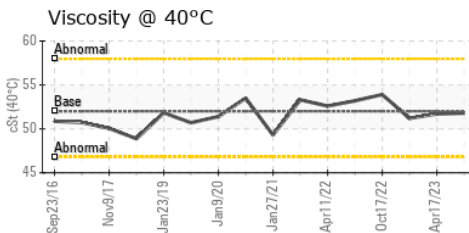
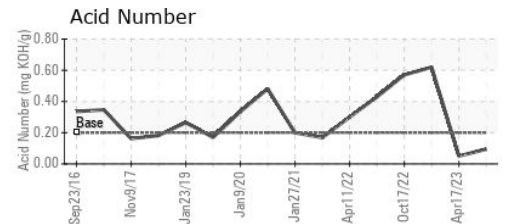
GRAPHS

All component wear rates are normal.

There is no indication of any contamination in the oil.

The AN level is acceptable for this fluid. The condition of the oil is suitable for further service.

Resample at the next service interval to monitor.
