OIL ANALYSIS REPORT

Area
AREA II [500313489]
 Machine Id
CHEMINEER A0495 (S/N AD-3-35)
 Component
Gearbox
 Fluid
ROYAL PURPLE SYNFILM GT 220 (3 GAL)

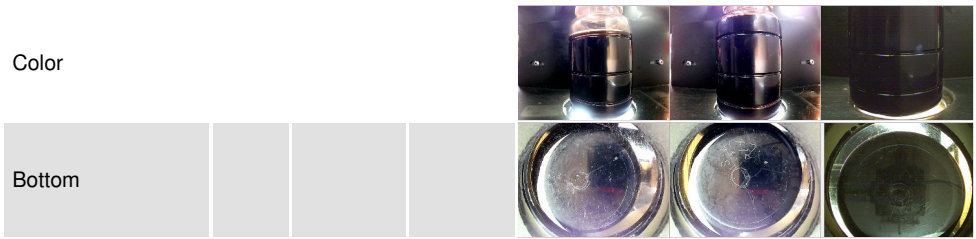
SAMPLE IMAGES	method	limit/base	current	history1	history2
---------------	--------	------------	---------	----------	----------

VISUAL	method	limit/base	current	history1	history2
White Metal	scalar	*Visual	NONE	NONE	NONE
Yellow Metal	scalar	*Visual	NONE	NONE	NONE
Precipitate	scalar	*Visual	NONE	NONE	NONE
Silt	scalar	*Visual	NONE	NONE	NONE
Debris	scalar	*Visual	NONE	NONE	LIGHT
Sand/Dirt	scalar	*Visual	NONE	NONE	NONE
Appearance	scalar	*Visual	NORML	NORML	NORML
Odor	scalar	*Visual	NORML	NORML	NORML
Emulsified Water	scalar	*Visual	>0.2	NEG	NEG
Free Water	scalar	*Visual		NEG	NEG

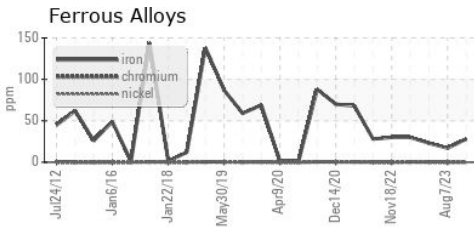
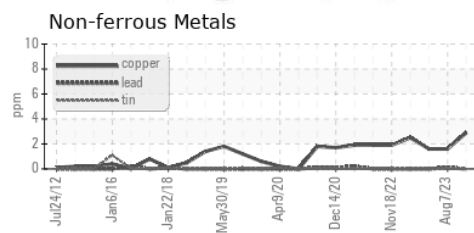
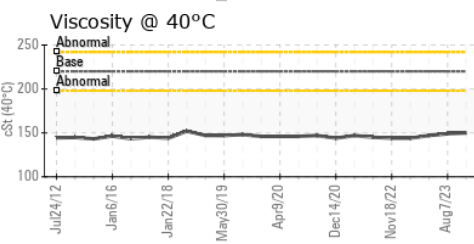
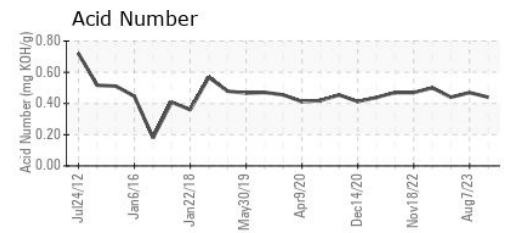
GRAPHS

All component wear rates are normal.

Resample at the next service interval to monitor.
