OIL ANALYSIS REPORT

Area
AREA II [500312491]
 Machine Id
CHEMINEER A5003 (S/N AD-15-32)
 Component
Gearbox
 Fluid
ROYAL PURPLE SYNFILM GT 220 (5 GAL)

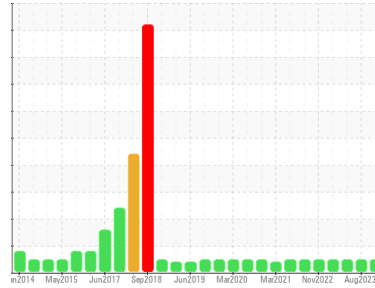
Sample Rating Trend

NORMAL

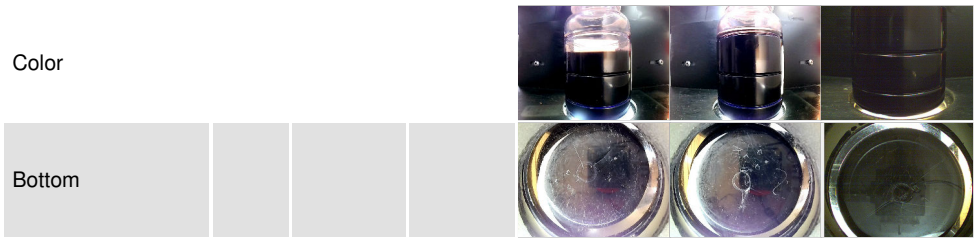
SAMPLE IMAGES	method	limit/base	current	history1	history2
---------------	--------	------------	---------	----------	----------

VISUAL	method	limit/base	current	history1	history2
White Metal	scalar	*Visual	NONE	NONE	NONE
Yellow Metal	scalar	*Visual	NONE	NONE	NONE
Precipitate	scalar	*Visual	NONE	NONE	NONE
Silt	scalar	*Visual	NONE	NONE	NONE
Debris	scalar	*Visual	NONE	NONE	NONE
Sand/Dirt	scalar	*Visual	NONE	NONE	NONE
Appearance	scalar	*Visual	NORML	NORML	NORML
Odor	scalar	*Visual	NORML	NORML	NORML
Emulsified Water	scalar	*Visual	>0.2	NEG	NEG
Free Water	scalar	*Visual		NEG	NEG

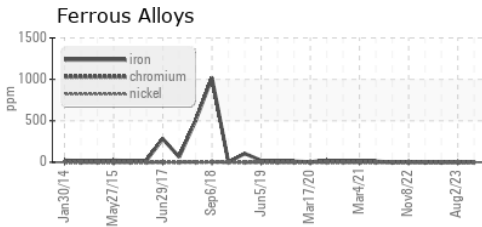
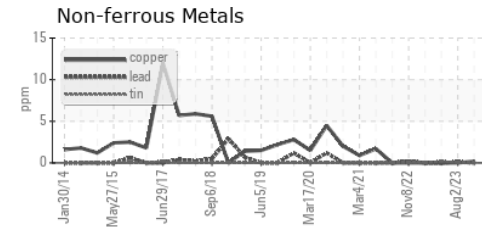
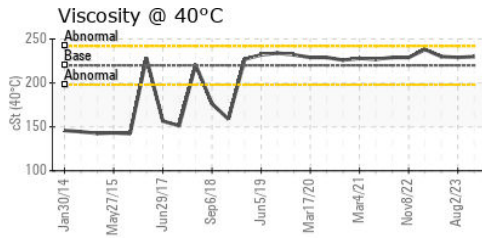
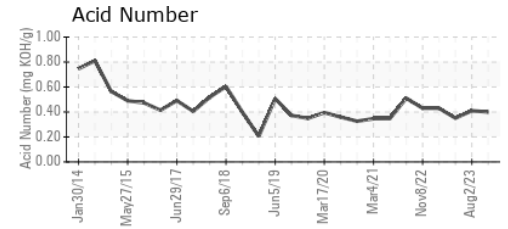
GRAPHS

All component wear rates are normal.

There is no indication of any contamination in the oil.

The AN level is acceptable for this fluid. The condition of the oil is suitable for further service.

Resample at the next service interval to monitor.
