OIL ANALYSIS REPORT

Machine Id
CATERPILLAR D10T 15105048 (S/N CCAT0D10THRJG01478)
 Component
Right Final Drive
 Fluid
CHEVRON 50WT (--- GAL)

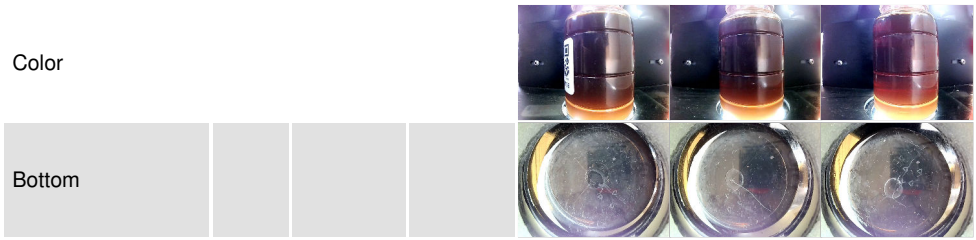
SAMPLE IMAGES		method	limit/base	current	history1	history2
---------------	--	--------	------------	---------	----------	----------

method	limit/base	current	history1	history2
White Metal	scalar	*Visual NONE	NONE	NONE	LIGHT
Yellow Metal	scalar	*Visual NONE	NONE	NONE	NONE
Precipitate	scalar	*Visual NONE	NONE	NONE	NONE
Silt	scalar	*Visual NONE	NONE	NONE	NONE
Debris	scalar	*Visual NONE	NONE	NONE	NONE
Sand/Dirt	scalar	*Visual NONE	NONE	NONE	NONE
Appearance	scalar	*Visual NORML	NORML	NORML	NORML
Odor	scalar	*Visual NORML	NORML	NORML	NORML
Emulsified Water	scalar	*Visual >0.2	NEG	NEG	NEG
Free Water	scalar	*Visual	NEG	NEG	NEG

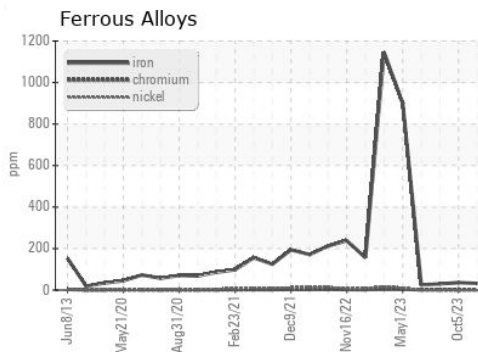
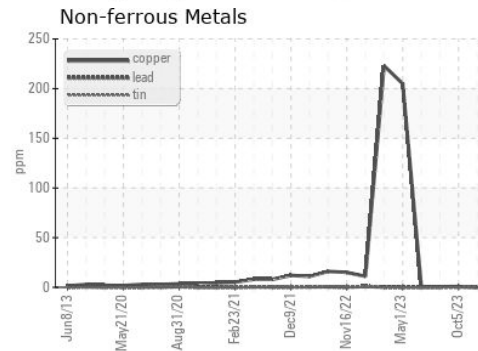
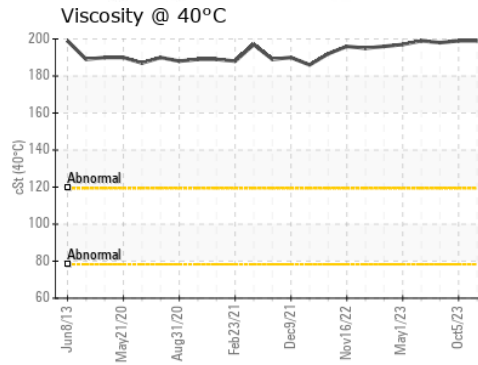
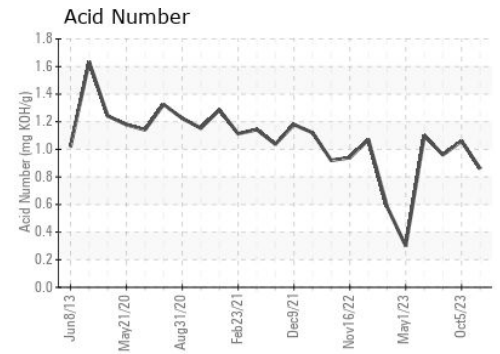
GRAPHS

- Recommendation**
Resample at the next service interval to monitor.
- Wear**
All component wear rates are normal.
- Contamination**
There is no indication of any contamination in the oil.
- Fluid Condition**
The AN level is acceptable for this fluid. The condition of the oil is suitable for further service.
