Area
PALEXTRA 44
Machine Id
SULLIVAN PALATEK 1805150004 - COMP 1 - GOPHER RESOURCES
Component
Compressor

OIL ANALYSIS REPORT

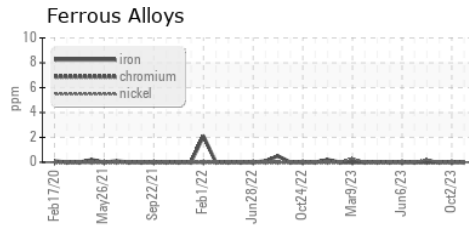
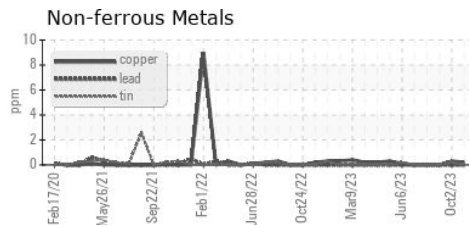
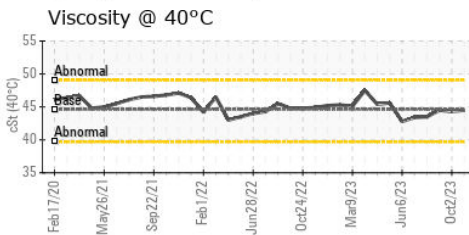
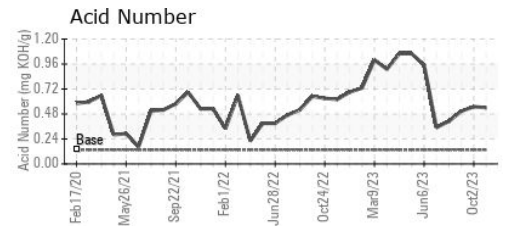
GRAPHS

All component wear rates are normal.

The AN level is acceptable for this fluid. The condition of the oil is suitable for further service.

Resample at the next service interval to monitor.
