Customer Id: ENEKAR
Sample No.: RP0036176
Lab Number: 06016555
Test Package: IND 2

OIL ANALYSIS REPORT

Machine Id
MLU-2
Component
Inboard Pump
Fluid
ROYAL PURPLE SYNFILM GT 32 (--- GAL)

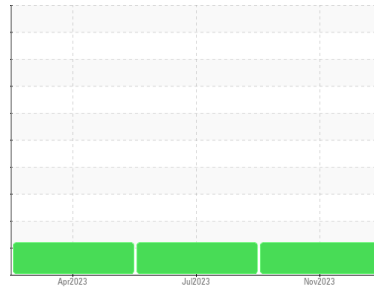
Sample Rating Trend

VISUAL METAL

Sample Status				ABNORMAL	ABNORMAL	ABNORMAL
White Metal	scalar	*Visual	NONE	▲ MODER	▲ MODER	▲ MODER

We suspect abnormal metal contamination may be due to sampling method. No corrective action is recommended at this time. Resample at the next service interval to monitor.

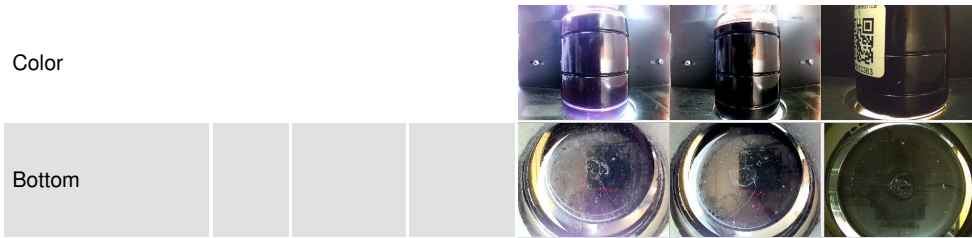
SAMPLE IMAGES		method	limit/base	current	history1	history2
---------------	--	--------	------------	---------	----------	----------

Moderate concentration of visible metal present. All component wear rates are normal.

We suspect abnormal metal contamination may be due to sampling method. No corrective action is recommended at this time. Resample at the next service interval to monitor.
