Machine Id
MLU-2
 Component
Outboard Pump
 Fluid
ROYAL PURPLE SYNFILM GT 32 (--- GAL)

Customer Id: ENELONRP
 Sample No.: RP0037129
 Lab Number: 06016563
 Test Package: IND 2

OIL ANALYSIS REPORT

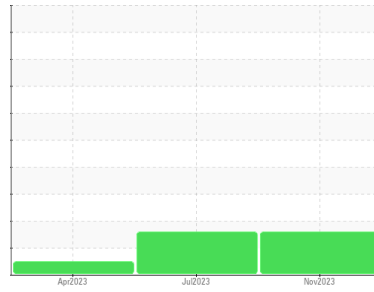
Sample Rating Trend

VISUAL METAL

We suspect abnormal contamination may be due to sampling method. No corrective action is recommended at this time. Resample at the next service interval to monitor.

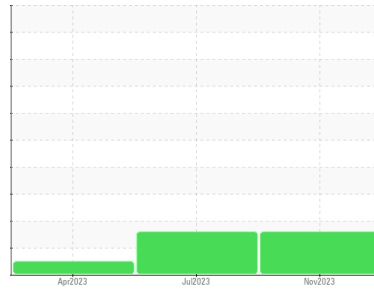
Sample Rating Trend

VISUAL METAL

Moderate concentration of visible metal present. All component wear rates are normal.

Moderate concentration of visible dirt/debris present in the oil. The water content is negligible.

We suspect abnormal contamination may be due to sampling method. No corrective action is recommended at this time. Resample at the next service interval to monitor.
