# PROBLEM SUMMARY

Machine Id  
**800 HP**  
Component  
**Outboard Bearing**  
Fluid  
**ROYAL PURPLE SYNFILM GT 32 (--- GAL)**

# OIL ANALYSIS REPORT

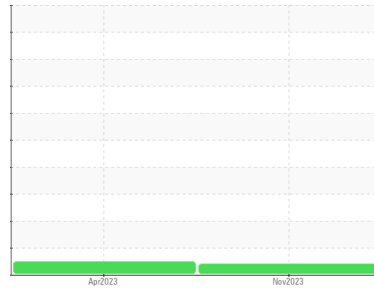
Sample Rating Trend

#### ▲ Viscosity @ 40°C

Sample Status				ATTENTION	NORMAL	---
Visc @ 40°C	cSt	ASTM D445	32	▲ 135.3	161	---

The oil viscosity is higher than normal. Confirm oil type. The AN level is acceptable for this fluid.

No corrective action is recommended at this time.  
Resample at the next service interval to monitor.

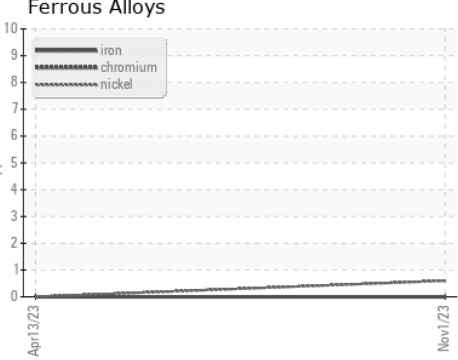
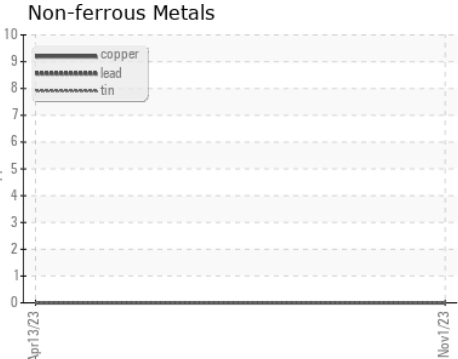
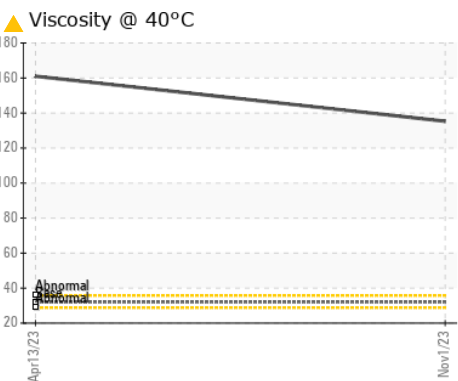
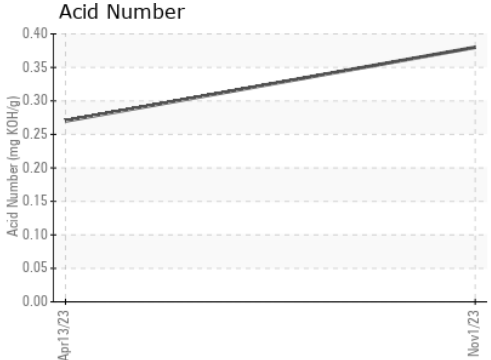
### GRAPHS

method	limit/base	current	history1	history2
Visc @ 40°C	cSt ASTM D445	▲ 135.3	161	---

No corrective action is recommended at this time. Resample at the next service interval to monitor.
