Machine Id
KAESER AIR TOWER 7.5C 5406104 (S/N 1062)
 Component
Compressor
 Fluid
KAESER SIGMA (OEM) S-460 (--- GAL)

Customer Id: REPCAV
 Sample No.: KCPA010278
 Lab Number: 06025741
 Test Package: IND 2

OIL ANALYSIS REPORT

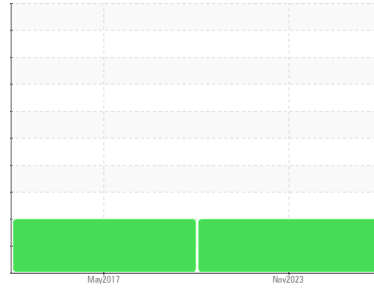
Sample Rating Trend

▲ Particle Trend

Sample Status			ABNORMAL	ABNORMAL	---
Particles >6µm	ASTM D7647	>1300	▲ 1729	▲ 13096	---
Particles >14µm	ASTM D7647	>80	▲ 328	▲ 1575	---
Particles >21µm	ASTM D7647	>20	▲ 107	▲ 375	---
Particles >38µm	ASTM D7647	>4	▲ 6	▲ 18	---
Oil Cleanliness	ISO 4406 (c)	>--/17/13	▲ 19/18/16	▲ 21/18	---

No corrective action is recommended at this time. The filter change at the time of sampling has been noted. Resample at the next service interval to monitor.

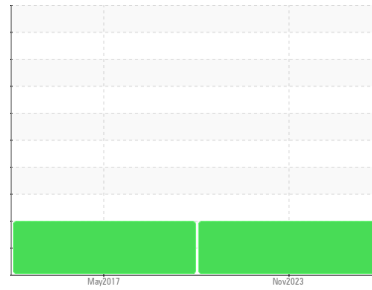
Sample Rating Trend

All component wear rates are normal.

The AN level is acceptable for this fluid. The condition of the oil is suitable for further service.

No corrective action is recommended at this time. The filter change at the time of sampling has been noted. Resample at the next service interval to monitor.
