PROBLEM SUMMARY

Machine Id
CYG_MLU3
Component
Outboard Pump
Fluid
NOT GIVEN (--- GAL)

OIL ANALYSIS REPORT

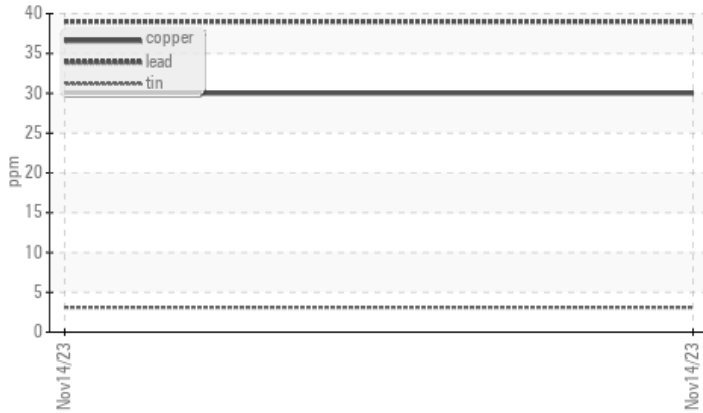
COMPONENT CONDITION SUMMARY

▲ Non-ferrous Metals

Sample Status				ABNORMAL	---	---
Lead	ppm	ASTM D5185m	>12	▲ 39	---	---
Copper	ppm	ASTM D5185m	>30	▲ 30	---	---
Yellow Metal	scalar	*Visual	NONE	▲ MODER	---	---

Wear
 Moderate concentration of visible metal present. Bearing and/or bushing wear is indicated.

We advise that you inspect for the source(s) of wear. We recommend an early resample to monitor this condition.
