Machine Id
HEB_MLU4
 Component
Lube System
 Fluid
NOT GIVEN (--- GAL)

Customer Id: ENEHEB
Sample No.: RP0036155
Lab Number: 06026615
Test Package: IND 2

OIL ANALYSIS REPORT

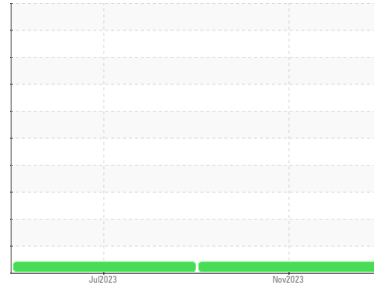
Sample Rating Trend

VIS DEBRIS

Sample Status				ABNORMAL	ABNORMAL	---
Debris	scalar	*Visual	NONE	▲ MODER	▲ MODER	---

We suspect abnormal contamination may be due to sampling method. No corrective action is recommended at this time. Resample at the next service interval to monitor.

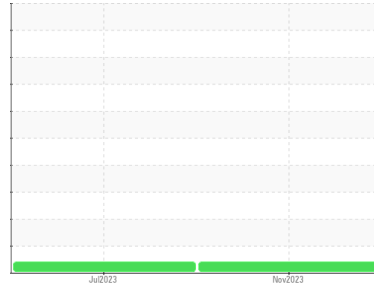
Sample Rating Trend

VIS DEBRIS

Moderate concentration of visible dirt/debris present in the oil. The water content is negligible.

We suspect abnormal contamination may be due to sampling method. No corrective action is recommended at this time. Resample at the next service interval to monitor.
