OIL ANALYSIS REPORT

Area
CAPL - HYDRAULIC
Machine Id
CAPL SKIN PASS HYD UNIT (S/N 16-3100-1510)

Component
Hydraulic System
Fluid
AW HYDRAULIC OIL ISO 46 (--- QTS)

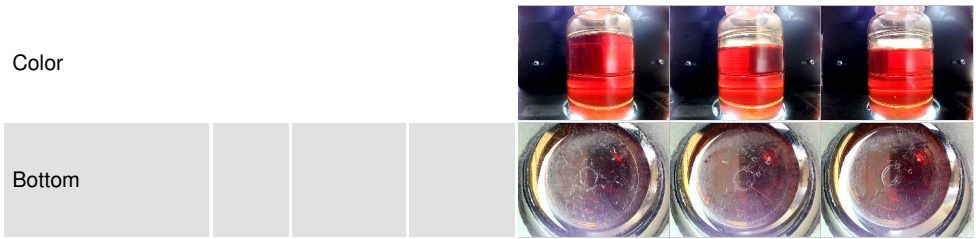
SAMPLE IMAGES	method	limit/base	current	history1	history2
---------------	--------	------------	---------	----------	----------

VISUAL	method	limit/base	current	history1	history2
White Metal	scalar	*Visual	NONE	NONE	NONE
Yellow Metal	scalar	*Visual	NONE	NONE	NONE
Precipitate	scalar	*Visual	NONE	NONE	NONE
Silt	scalar	*Visual	NONE	NONE	NONE
Debris	scalar	*Visual	NONE	LIGHT	NONE
Sand/Dirt	scalar	*Visual	NONE	NONE	NONE
Appearance	scalar	*Visual	NORML	NORML	NORML
Odor	scalar	*Visual	NORML	NORML	NORML
Emulsified Water	scalar	*Visual	>0.05	NEG	NEG
Free Water	scalar	*Visual		NEG	NEG

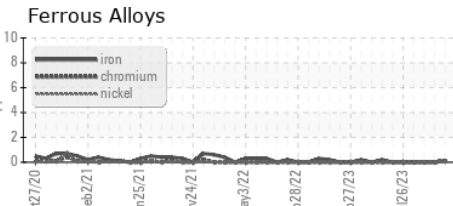
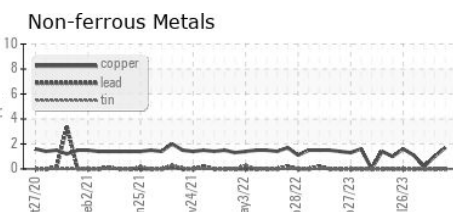
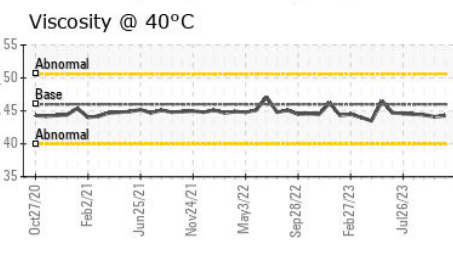
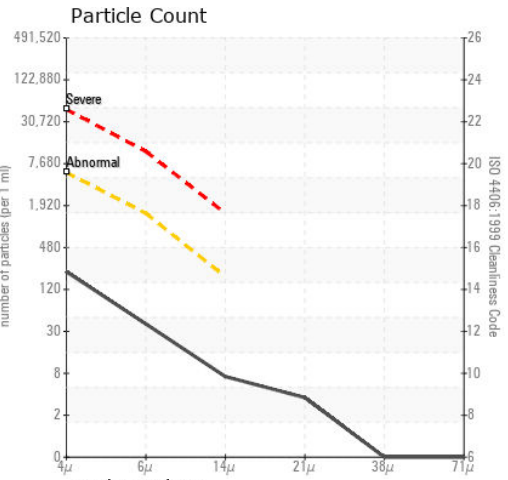
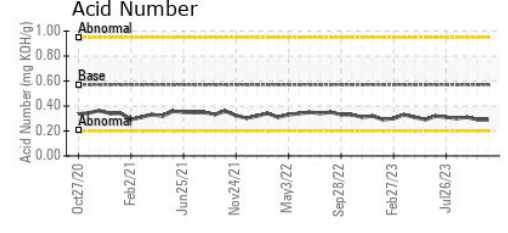
GRAPHS

All component wear rates are normal.

The system cleanliness is acceptable for your target ISO 4406 cleanliness code. The water content is negligible. The system and fluid cleanliness is acceptable.

The AN level is acceptable for this fluid. The condition of the oil is suitable for further service.

Little or no information is provided as to the component and lubricant being tested. Recommendations are therefore generic in nature and may not apply to the current application. Please forward information as to equipment type, reservoir capacity, lubricant type and any pertinent information to allow for a more accurate assessment. Resample at the next service interval to monitor. NOTE: Please provide information regarding reservoir capacity, filter type and micron rating with next sample. Please specify the brand, type, and viscosity of the oil on your next sample.
