# PROBLEM SUMMARY

Machine Id  
**JOHN DEERE 648L 1DW648LBLKF695802**  
 Component  
**Hydraulic System**  
 Fluid  
**NOT GIVEN (--- GAL)**

# OIL ANALYSIS REPORT

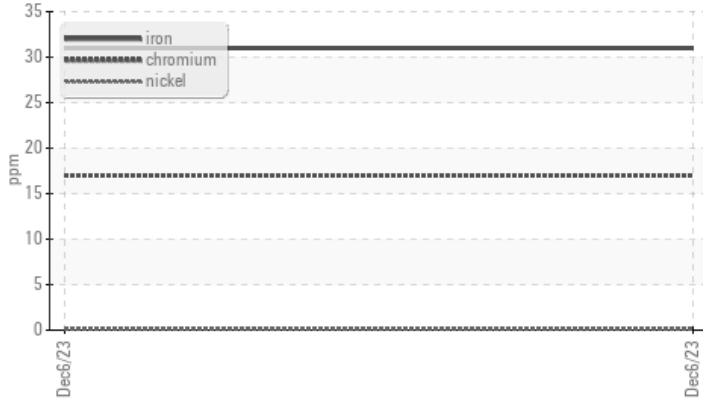
### ▲ Ferrous Alloys

Sample Status	ABNORMAL		---	---
Iron	ppm	ASTM D5185m >20	▲ 31	---
Chromium	ppm	ASTM D5185m >10	▲ 17	---

The iron level is abnormal. The chromium level is abnormal.

No corrective action is recommended at this time.  
 Resample at the next service interval to monitor.

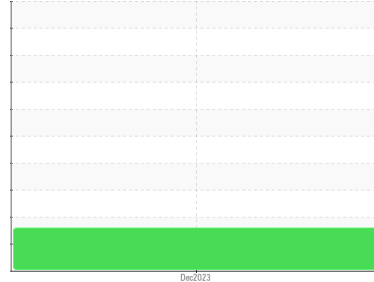
Sample Rating Trend

There is no indication of any contamination in the oil. The amount and size of particulates present in the system are acceptable.

The AN level is acceptable for this fluid. The condition of the oil is acceptable for the time in service.

No corrective action is recommended at this time. Resample at the next service interval to monitor.
