OIL ANALYSIS REPORT

Area
SIGMA [SP2515815]
 Machine Id
KAESER 1013-2 - BAY AREA PRODUCTION SERVICES
 Component
Compressor

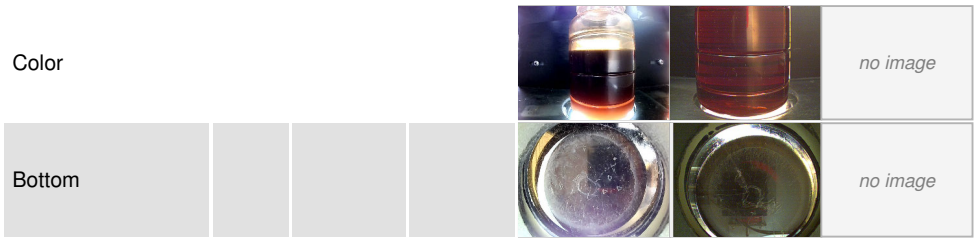
| SAMPLE IMAGES | method | limit/base | current | history1 | history2 |

| VISUAL | method | limit/base | current | history1 | history2 |
|---|---|---|---|---|---|
| Appearance | scalar | *Visual | NORML | NORML | --- |
| Odor | scalar | *Visual | NORML | NORML | --- |
