OIL ANALYSIS REPORT

Area
DF8
 Machine Id
KAESER 615-NESTLE PURINA (S/N 1066)
 Component
Compressor

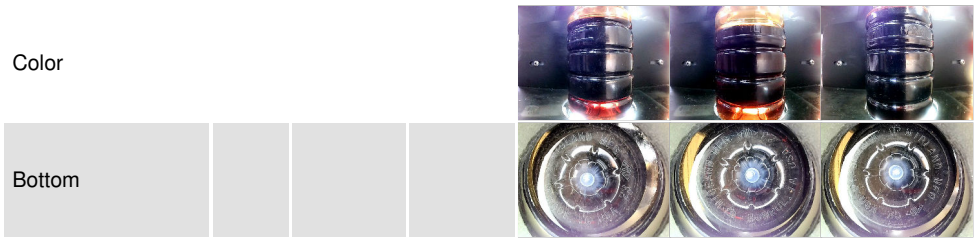
SAMPLE IMAGES	method	limit/base	current	history1	history2
---------------	--------	------------	---------	----------	----------

VISUAL	method	limit/base	current	history1	history2
White Metal	scalar	*Visual	NONE	NONE	NONE
Yellow Metal	scalar	*Visual	NONE	NONE	NONE
Precipitate	scalar	*Visual	NONE	NONE	NONE
Silt	scalar	*Visual	NONE	NONE	NONE
Debris	scalar	*Visual	NONE	NONE	NONE
Sand/Dirt	scalar	*Visual	NONE	NONE	NONE
Appearance	scalar	*Visual	NORML	NORML	NORML
Odor	scalar	*Visual	NORML	NORML	NORML
Emulsified Water	scalar	*Visual	>0.05	NEG	NEG
Free Water	scalar	*Visual		NEG	NEG

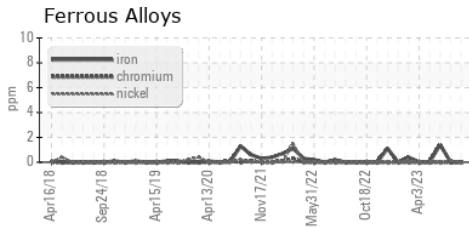
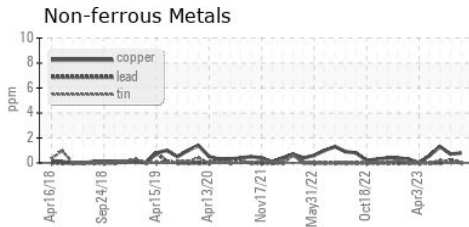
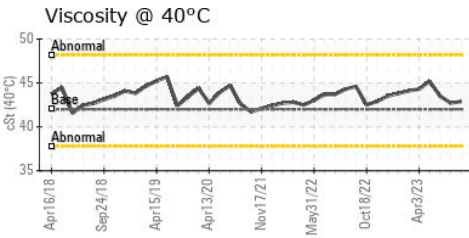
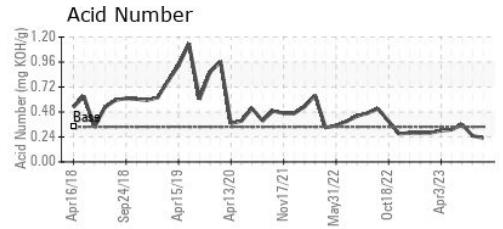
GRAPHS

All component wear rates are normal.

There is no indication of any contamination in the oil.

The AN level is acceptable for this fluid. The condition of the oil is suitable for further service.

Resample at the next service interval to monitor.
