OIL ANALYSIS REPORT

Area
GUAY SON [CONHER]
 Machine Id
PISA 4 SH - Pacifico Industrial
 Component
Hydraulic System
 Fluid
ISO 68 (1000 LTR)

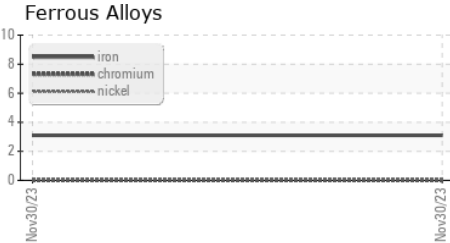
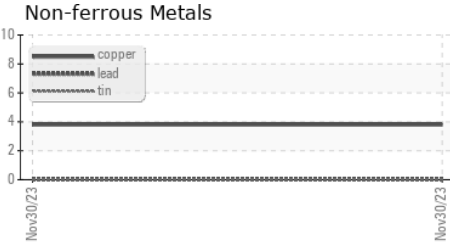
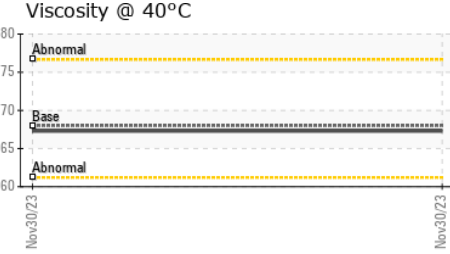
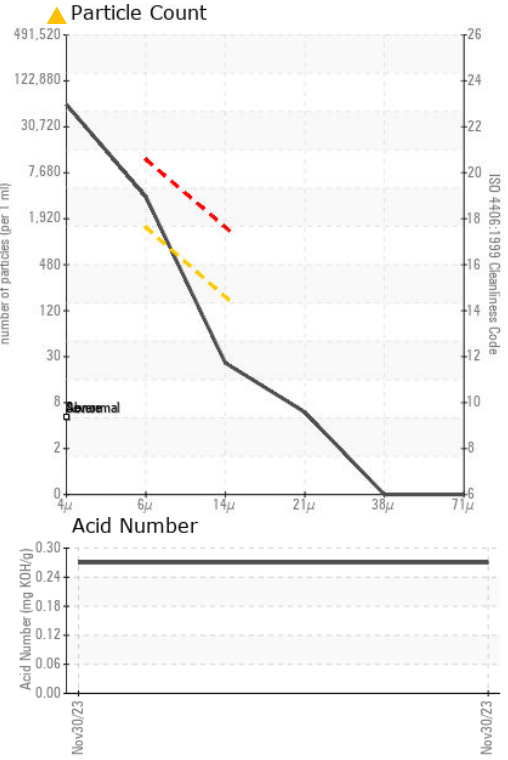
GRAPHS

There is a high amount of silt (particulates < 14 microns in size) present in the oil.

No corrective action is recommended at this time. Resample at the next service interval to monitor. (after 4 hours Kleenoil filtration). (Customer Sample Comment: After 4 hours of kleenoil filtration)
