Machine Id
KAESER 2660217
 Component
Compressor
 Fluid
KAESER SIGMA (OEM) M-460 (--- GAL)

Customer Id: CITPALCA
 Sample No.: KCPA010821
 Lab Number: 06029383
 Test Package: IND 2

OIL ANALYSIS REPORT

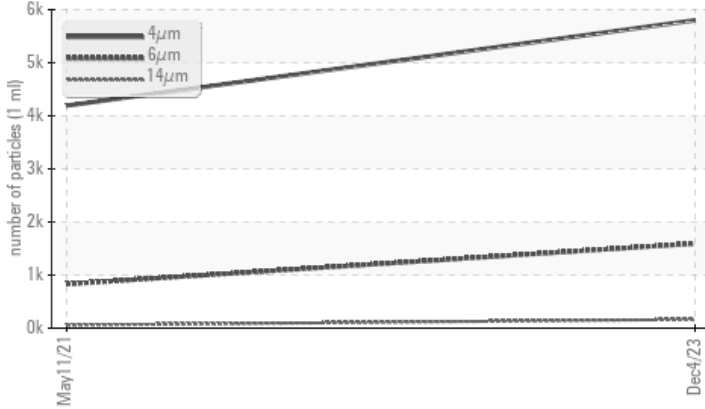
▲ Particle Trend

Sample Status			ABNORMAL	NORMAL	---
Particles >6µm	ASTM D7647	>1300	▲ 1594	830	---
Particles >14µm	ASTM D7647	>80	▲ 164	56	---
Particles >21µm	ASTM D7647	>20	▲ 45	13	---
Oil Cleanliness	ISO 4406 (c)	>--/17/13	▲ 20/18/15	17/13	---

There is a high amount of particulates present in the oil.

No corrective action is recommended at this time. The filter change at the time of sampling has been noted. Resample at the next service interval to monitor.

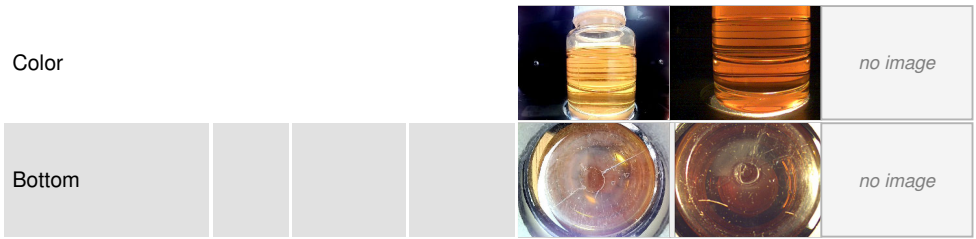
SAMPLE IMAGES

VISUAL	method	limit/base	current	history1	history2
White Metal	scalar	*Visual	NONE	NONE	---
Yellow Metal	scalar	*Visual	NONE	NONE	---
Precipitate	scalar	*Visual	NONE	NONE	---
Silt	scalar	*Visual	NONE	NONE	---
Debris	scalar	*Visual	NONE	NONE	---
Sand/Dirt	scalar	*Visual	NONE	NONE	---
Appearance	scalar	*Visual	NORML	NORML	---
Odor	scalar	*Visual	NORML	NORML	---
Emulsified Water	scalar	*Visual	>0.05	NEG	---
Free Water	scalar	*Visual		NEG	---
