OIL ANALYSIS REPORT

405

Hydraulic System

MOBIL DTE ULTRA 24 ISO 32 (--- GAL)

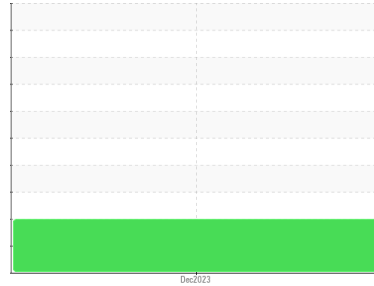
Sample Rating Trend

▲ Particle Trend

Sample Status			ABNORMAL	---	---
Particles >4µm	ASTM D7647	>10000	▲ 37789	---	---
Particles >6µm	ASTM D7647	>2500	▲ 10489	---	---
Particles >14µm	ASTM D7647	>320	▲ 1053	---	---
Particles >21µm	ASTM D7647	>80	▲ 304	---	---
Oil Cleanliness	ISO 4406 (c)	>20/18/15	▲ 22/21/17	---	---

We recommend you service the filters on this component. Resample at the next service interval to monitor.

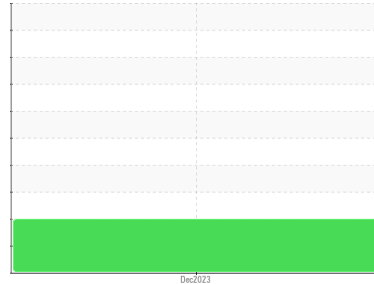
Sample Rating Trend

There is a high amount of particulates present in the oil.

FLUID CLEANLINESS		method	limit/base	current	history1	history2
Particles >4µm		ASTM D7647	>10000	▲ 37789	---	---
Particles >6µm		ASTM D7647	>2500	▲ 10489	---	---
Particles >14µm		ASTM D7647	>320	▲ 1053	---	---
Particles >21µm		ASTM D7647	>80	▲ 304	---	---
Particles >38µm		ASTM D7647	>20	9	---	---
Particles >71µm		ASTM D7647	>4	1	---	---
Oil Cleanliness		ISO 4406 (c)	>20/18/15	▲ 22/21/17	---	---

We recommend you service the filters on this component. Resample at the next service interval to monitor.
