PROBLEM SUMMARY

Machine Id
1800 TON PRESS

Component
Hydraulic System

OIL ANALYSIS REPORT

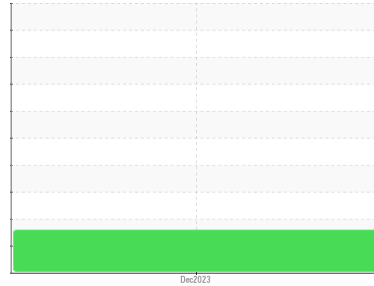
Sample Rating Trend

▲ Particle Trend

Sample Status				ABNORMAL	---	---
Particles >4µm	ASTM D7647	>10000	▲ 63572	---	---	
Particles >6µm	ASTM D7647	>2500	▲ 11528	---	---	
Particles >14µm	ASTM D7647	>320	▲ 348	---	---	
Oil Cleanliness	ISO 4406 (c)	>20/18/15	▲ 23/21/16	---	---	
PrtFilter				no image	no image

We recommend you service the filters on this component. Resample at the next service interval to monitor. Please specify the brand, type, and viscosity of the oil on your next sample.

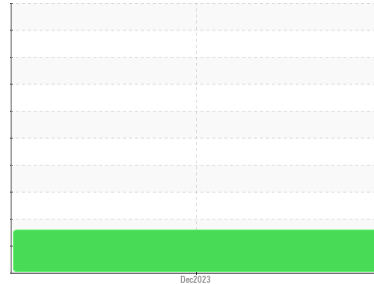
Sample Rating Trend

All component wear rates are normal.

The AN level is acceptable for this fluid. The condition of the oil is suitable for further service.

We recommend you service the filters on this component. Resample at the next service interval to monitor. Please specify the brand, type, and viscosity of the oil on your next sample.
