OIL ANALYSIS REPORT

Machine Id
CATERPILLAR D10T 15105050 (S/N CATOD10TCRJG01497)
 Component
Transmission (Manual)
 Fluid
RP CMT 50 (--- GAL)

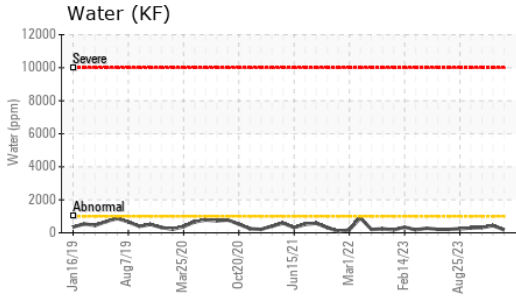
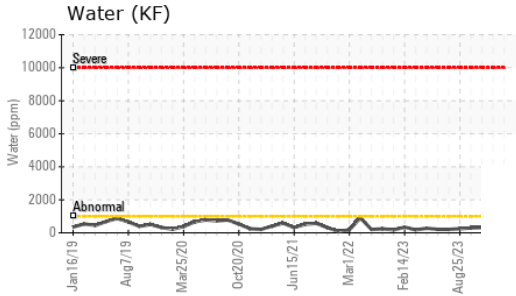
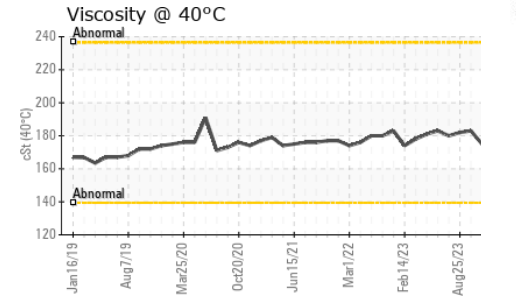
GRAPHS

All component wear rates are normal.

There is no indication of any contamination in the oil.

The AN level is acceptable for this fluid. The condition of the oil is suitable for further service.

Resample at the next service interval to monitor.

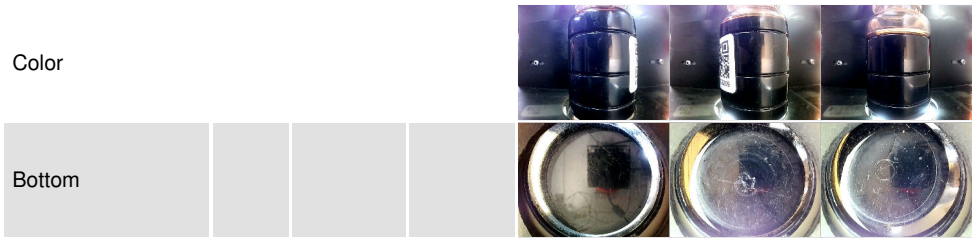
SAMPLE IMAGES		method	limit/base	current	history1	history2
---------------	--	--------	------------	---------	----------	----------

VISUAL		method	limit/base	current	history1	history2
White Metal	scalar	*Visual	NONE	NONE	NONE	NONE
Yellow Metal	scalar	*Visual	NONE	NONE	NONE	NONE
Precipitate	scalar	*Visual	NONE	NONE	NONE	NONE
Silt	scalar	*Visual	NONE	NONE	NONE	NONE
Debris	scalar	*Visual	NONE	NONE	NONE	NONE
Sand/Dirt	scalar	*Visual	NONE	NONE	NONE	NONE
Appearance	scalar	*Visual	NORML	NORML	NORML	NORML
Odor	scalar	*Visual	NORML	NORML	NORML	NORML
Emulsified Water	scalar	*Visual	>0.1	NEG	NEG	NEG
Free Water	scalar	*Visual		NEG	NEG	NEG
