Area
SMART OIL
 Machine Id
HERTZ VD025669 - TDA 5 (S/N VD025699)

Component
Compressor
 Fluid
SMARTOIL 6000 (--- GAL)

OIL ANALYSIS REPORT

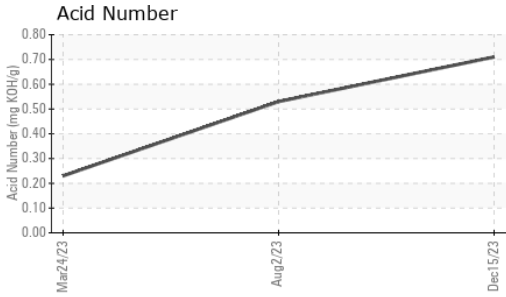
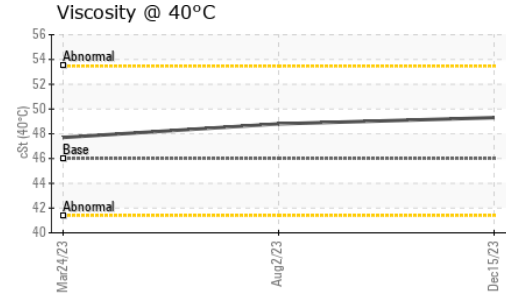
SAMPLE IMAGES	method	limit/base	current	history1	history2
---------------	--------	------------	---------	----------	----------

VISUAL	method	limit/base	current	history1	history2	
White Metal	scalar	*Visual	NONE	NONE	NONE	LIGHT
Yellow Metal	scalar	*Visual	NONE	NONE	NONE	NONE
Precipitate	scalar	*Visual	NONE	NONE	NONE	NONE
Silt	scalar	*Visual	NONE	NONE	NONE	NONE
Debris	scalar	*Visual	NONE	NONE	NONE	NONE
Sand/Dirt	scalar	*Visual	NONE	NONE	NONE	NONE
Appearance	scalar	*Visual	NORML	NORML	NORML	NORML
Odor	scalar	*Visual	NORML	NORML	NORML	NORML
Emulsified Water	scalar	*Visual	>0.1	NEG	NEG	NEG
Free Water	scalar	*Visual		NEG	NEG	NEG

FLUID PROPERTIES	method	limit/base	current	history1	history2
Visc @ 40°C	cSt	ASTM D445 46	49.3	48.8	47.7

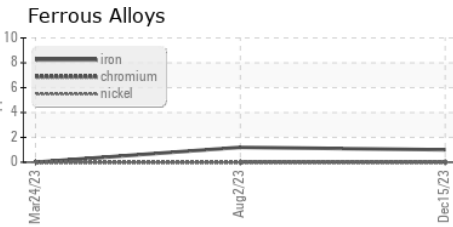
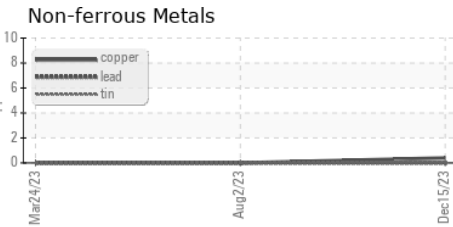
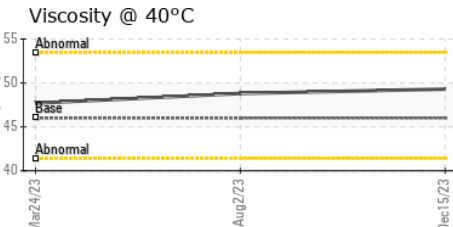
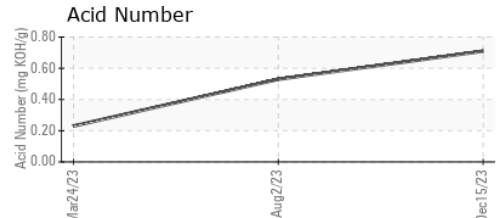
GRAPHS

All component wear rates are normal.

There is no indication of any contamination in the oil.

The AN level is acceptable for this fluid. The condition of the oil is suitable for further service.

Resample at the next service interval to monitor.
