OIL ANALYSIS REPORT

Machine Id
CHEVROLET 24886-03

Component
Transmission
Fluid
ATF (--- QTS)

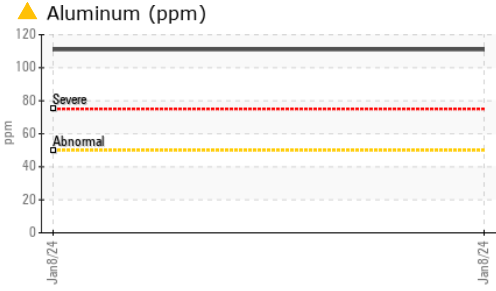
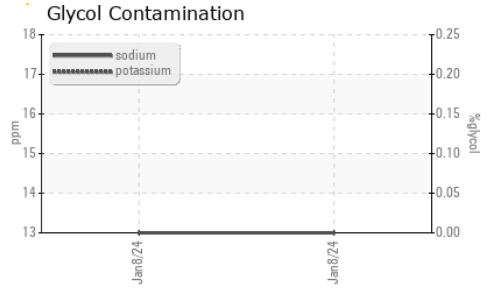
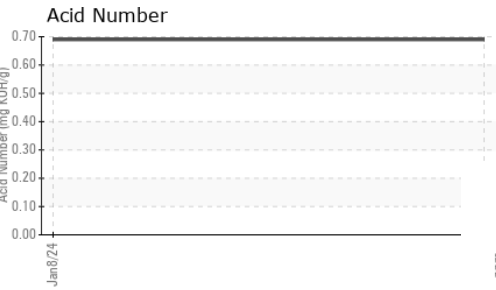
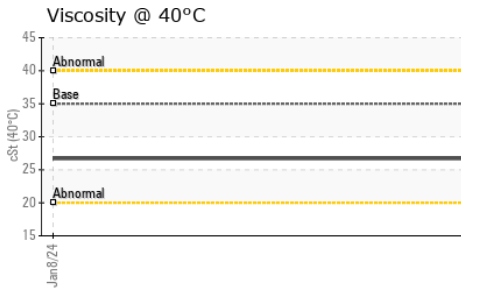
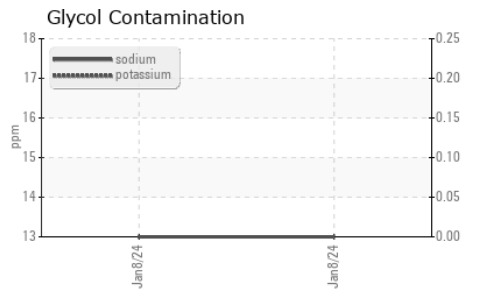
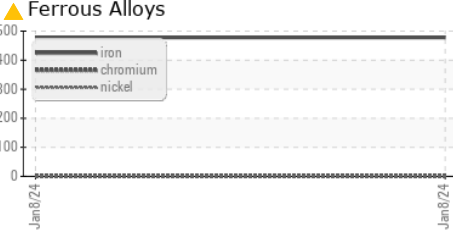
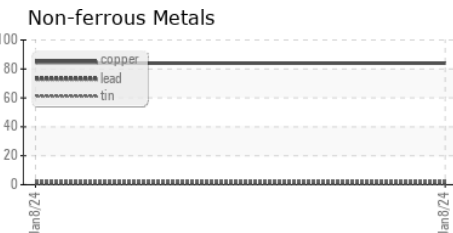
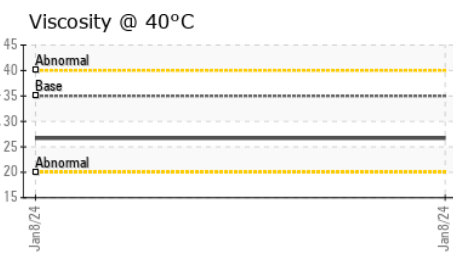
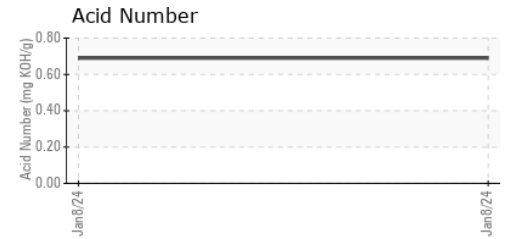
GRAPHS

Gear wear is indicated. Torque converter wear is indicated.

method	limit/base	current	history1	history2
Iron	ppm	ASTM D5185m >200	▲ 478	---	---
Chromium	ppm	ASTM D5185m >10	0	---	---
Nickel	ppm	ASTM D5185m	0	---	---
Titanium	ppm	ASTM D5185m	0	---	---
Silver	ppm	ASTM D5185m	0	---	---
Aluminum	ppm	ASTM D5185m >50	▲ 111	---	---
Lead	ppm	ASTM D5185m >50	<1	---	---
Copper	ppm	ASTM D5185m >200	84	---	---
Tin	ppm	ASTM D5185m >10	2	---	---
Vanadium	ppm	ASTM D5185m	0	---	---
Cadmium	ppm	ASTM D5185m	0	---	---

No corrective action is recommended at this time.
