Area
HERTZ SMART OIL 6000
Machine Id
HERTZ VD008641 - OVERHEAD DOOR OF PA
Component
Compressor
Fluid
SMARTOIL 6000 (--- GAL)

OIL ANALYSIS REPORT

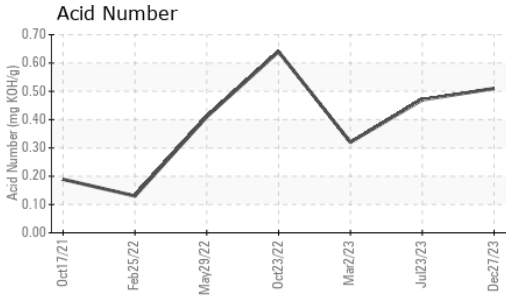
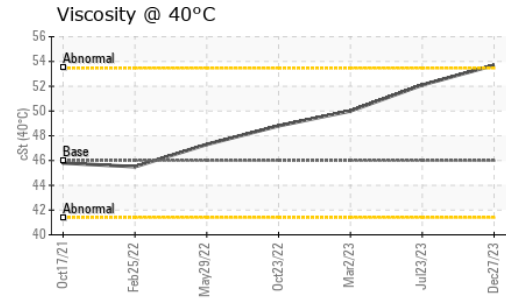
FLUID DEGRADATION		method	limit/base	current	history1	history2
Acid Number (AN)	mg KOH/g	ASTM D8045		0.51	0.47	0.32

FLUID PROPERTIES	method	limit/base	current	history1	history2
Visc @ 40°C	cSt	ASTM D445 46	53.7	52.1	50.0

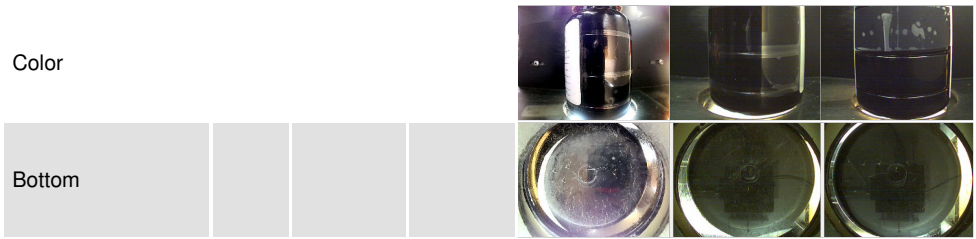
SAMPLE IMAGES	method	limit/base	current	history1	history2
---------------	--------	------------	---------	----------	----------

VISUAL	method	limit/base	current	history1	history2
White Metal	scalar	*Visual	NONE	NONE	NONE
Yellow Metal	scalar	*Visual	NONE	NONE	NONE
Precipitate	scalar	*Visual	NONE	NONE	NONE
Silt	scalar	*Visual	NONE	NONE	NONE
Debris	scalar	*Visual	NONE	NONE	NONE
Sand/Dirt	scalar	*Visual	NONE	NONE	NONE
Appearance	scalar	*Visual	NORML	NORML	NORML
Odor	scalar	*Visual	NORML	NORML	NORML
Emulsified Water	scalar	*Visual	>0.1	NEG	NEG
Free Water	scalar	*Visual		NEG	NEG

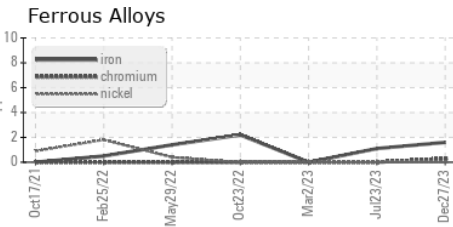
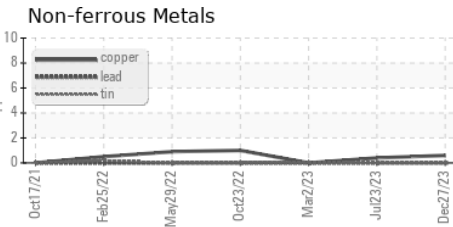
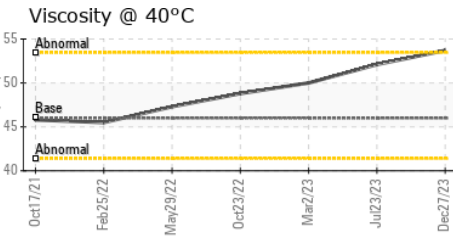
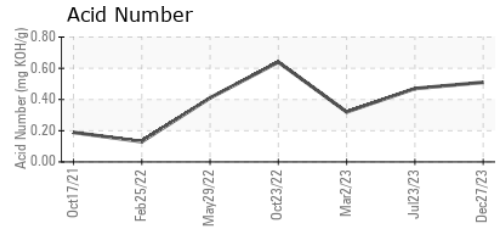
GRAPHS

WEAR METALS		method	limit/base	current	history1	history2
Iron	ppm	ASTM D5185m	>50	2	1	0
Chromium	ppm	ASTM D5185m	>10	<1	0	0
Nickel	ppm	ASTM D5185m		0	0	0
Titanium	ppm	ASTM D5185m		<1	0	0
Silver	ppm	ASTM D5185m		0	0	0
Aluminum	ppm	ASTM D5185m	>25	3	6	0
Lead	ppm	ASTM D5185m	>25	0	0	0
Copper	ppm	ASTM D5185m	>50	<1	<1	0
Tin	ppm	ASTM D5185m	>15	0	0	0
Vanadium	ppm	ASTM D5185m		0	<1	0
Cadmium	ppm	ASTM D5185m		0	0	0

Recommendation
Resample at the next service interval to monitor.
