OIL ANALYSIS REPORT

Area
[W48920]
Machine Id
JOHN DEERE 750K 1T0750KXEJF332859
Component
Right Outer Final Drive
Fluid
JOHN DEERE HY-GARD HYD/TRANS (--- GAL)

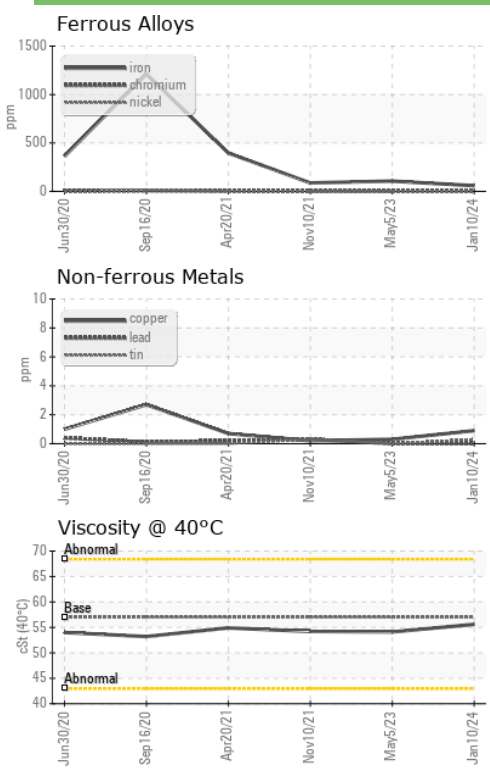
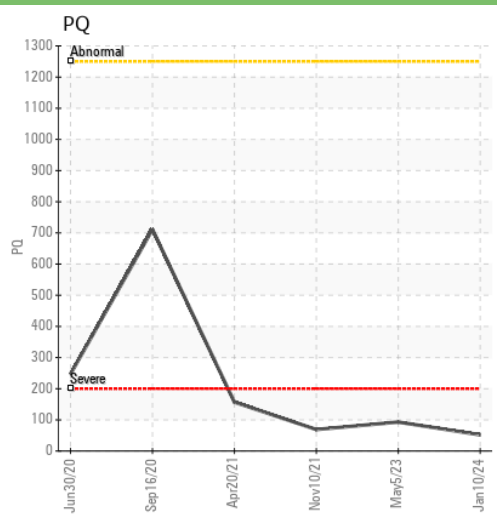
GRAPHS

All component wear rates are normal.

There is no indication of any contamination in the oil.

The condition of the oil is acceptable for the time in service.

Resample at the next service interval to monitor.
