OIL ANALYSIS REPORT

Area
TM 7
 Machine Id
TM 7 VISCONIP HYD 68
 Component
Hydraulic System
 Fluid
AW HYDRAULIC OIL ISO 68 (--- GAL)

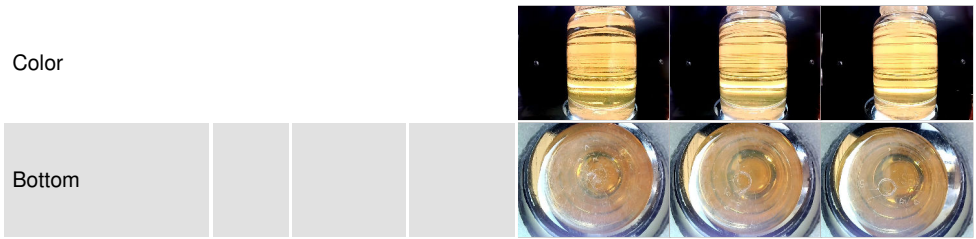
| SAMPLE IMAGES | method | limit/base | current | history1 | history2 |

| VISUAL | method | limit/base | current | history1 | history2 |
|---|---|---|---|---|---|
| Appearance | scalar | *Visual | NORML | NORML | NORML |
| Emulsified Water | scalar | *Visual | >0.05 | NEG | NEG |

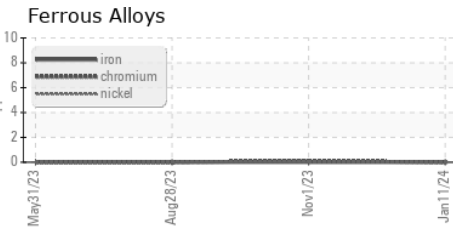
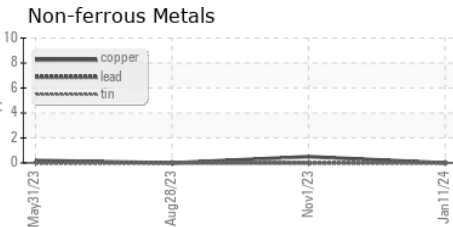
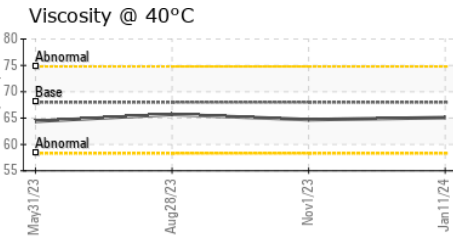
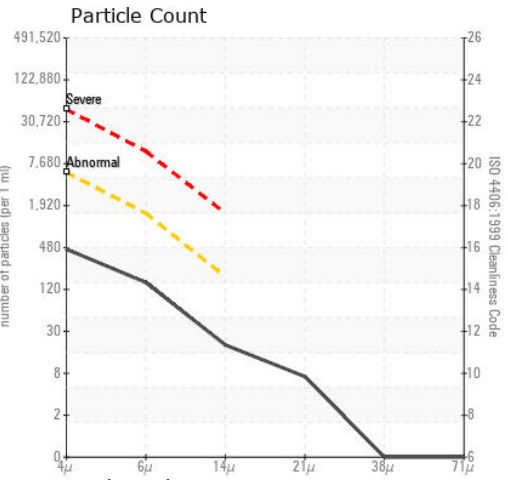
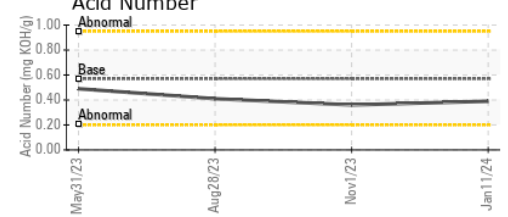
GRAPHS

All component wear rates are normal.

There is no indication of any contamination in the oil. The amount and size of particulates present in the system are acceptable.

The AN level is acceptable for this fluid. The condition of the oil is suitable for further service.

Resample at the next service interval to monitor.
