# OIL ANALYSIS REPORT

Area  
**DPO [7298]**  
 Machine Id  
**INGERSOLL RAND PX0317U02182 - RELIABLE MACHINE AND MANUFACTURING**  
 Component  
**Compressor**

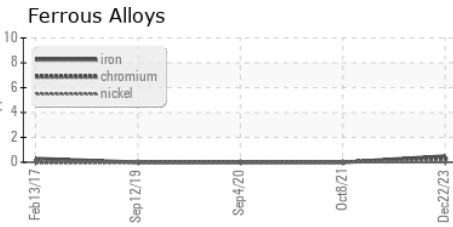
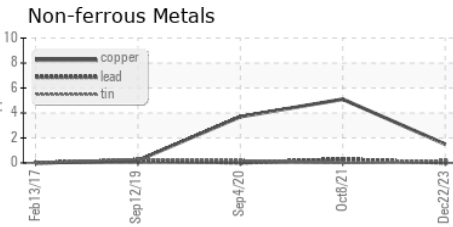
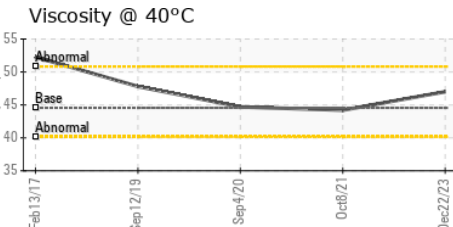
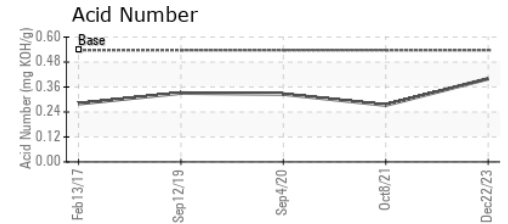
## GRAPHS

All component wear rates are normal.

There is no indication of any contamination in the oil.

The AN level is acceptable for this fluid. The condition of the oil is suitable for further service.

Resample at the next service interval to monitor.
