OIL ANALYSIS REPORT

Area
ACE-CSL-800S
 Machine Id
GARDNER DENVER 80587 - TEXTRON AVIATION (S/N U43468)
 Component
Compressor

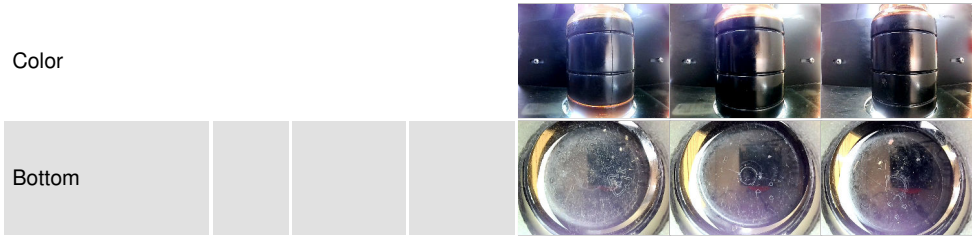
SAMPLE IMAGES	method	limit/base	current	history1	history2
---------------	--------	------------	---------	----------	----------

VISUAL	method	limit/base	current	history1	history2
White Metal	scalar	*Visual	NONE	NONE	NONE
Yellow Metal	scalar	*Visual	NONE	NONE	NONE
Precipitate	scalar	*Visual	NONE	NONE	NONE
Silt	scalar	*Visual	NONE	NONE	NONE
Debris	scalar	*Visual	NONE	NONE	NONE
Sand/Dirt	scalar	*Visual	NONE	NONE	NONE
Appearance	scalar	*Visual	NORML	NORML	NORML
Odor	scalar	*Visual	NORML	NORML	NORML
Emulsified Water	scalar	*Visual	>0.1	NEG	NEG
Free Water	scalar	*Visual		NEG	NEG
