OIL ANALYSIS REPORT

Area
[W48920]
Machine Id
JOHN DEERE 750K 1T0750KXEJF332859
Component
Left Inner Final Drive
Fluid
JOHN DEERE HY-GARD HYD/TRANS (--- GAL)

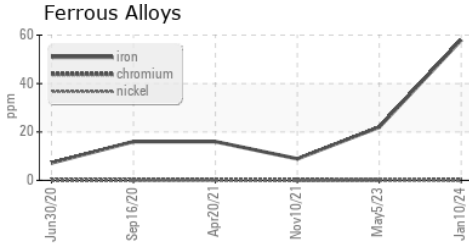
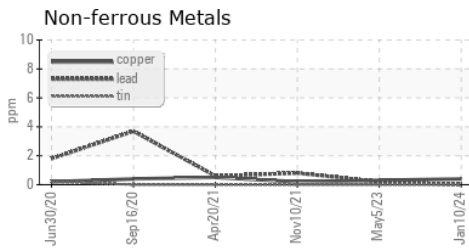
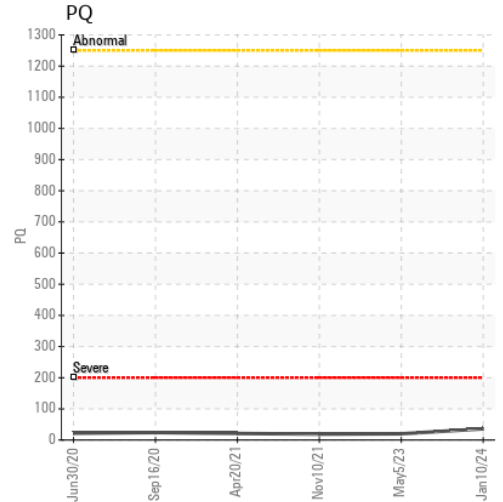
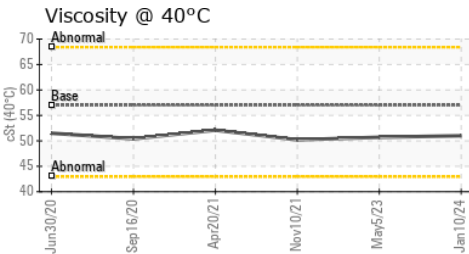
GRAPHS

All component wear rates are normal.

There is no indication of any contamination in the oil.

The condition of the oil is acceptable for the time in service.

Resample at the next service interval to monitor.
