OIL ANALYSIS REPORT

Area
AREA III [500315916]
 Machine Id
PFAUDLER A9120 (S/N 39187)
 Component
Gearbox
 Fluid
MOBIL SHC 634 (5 GAL)

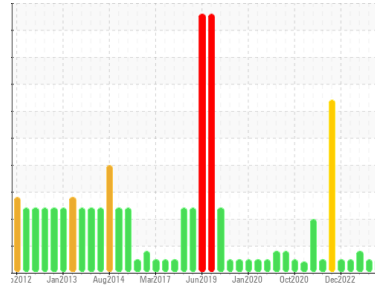
Sample Rating Trend

NORMAL

Resample at the next service interval to monitor.

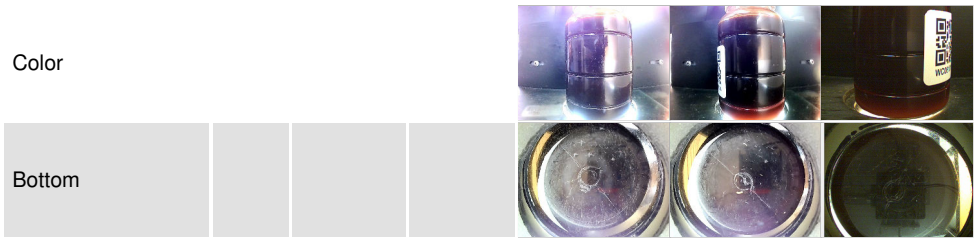
SAMPLE IMAGES	method	limit/base	current	history1	history2
---------------	--------	------------	---------	----------	----------

VISUAL	method	limit/base	current	history1	history2
White Metal	scalar	*Visual	NONE	NONE	NONE
Yellow Metal	scalar	*Visual	NONE	NONE	NONE
Precipitate	scalar	*Visual	NONE	NONE	NONE
Silt	scalar	*Visual	NONE	NONE	LIGHT
Debris	scalar	*Visual	NONE	NONE	NONE
Sand/Dirt	scalar	*Visual	NONE	NONE	NONE
Appearance	scalar	*Visual	NORML	NORML	NORML
Odor	scalar	*Visual	NORML	NORML	NORML
Emulsified Water	scalar	*Visual	>0.2	NEG	NEG
Free Water	scalar	*Visual		NEG	NEG

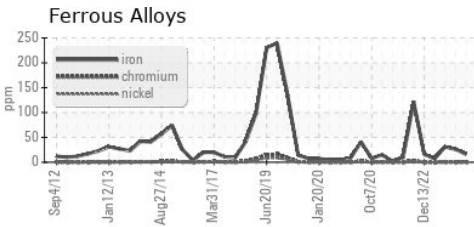
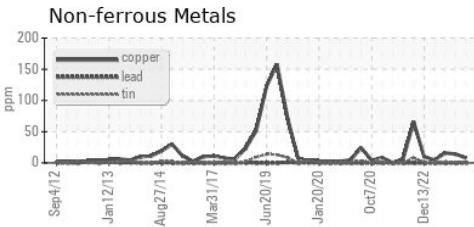
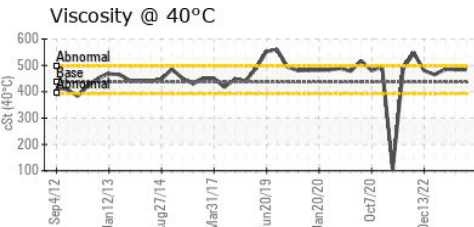
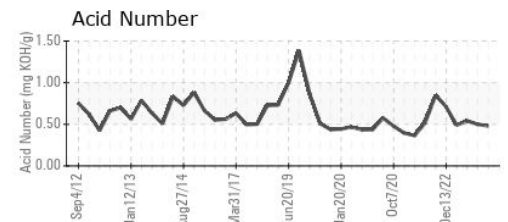
GRAPHS

All component wear rates are normal.

There is no indication of any contamination in the oil.

The AN level is acceptable for this fluid. The condition of the oil is suitable for further service.
