OIL ANALYSIS REPORT

Area
AREA II [500314958]
 Machine Id
CHEMINEER A0401 (S/N AD-10-21)
 Component
Gearbox
 Fluid
ROYAL PURPLE SYNFILM GT 220 (3 GAL)

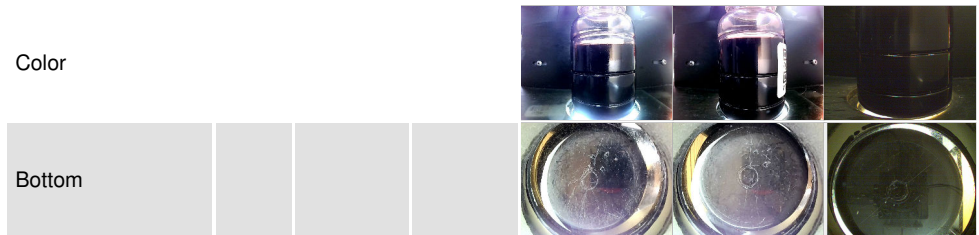
SAMPLE IMAGES	method	limit/base	current	history1	history2
---------------	--------	------------	---------	----------	----------

VISUAL	method	limit/base	current	history1	history2
White Metal	scalar	*Visual	NONE	NONE	NONE
Yellow Metal	scalar	*Visual	NONE	NONE	NONE
Precipitate	scalar	*Visual	NONE	NONE	NONE
Silt	scalar	*Visual	NONE	NONE	NONE
Debris	scalar	*Visual	NONE	NONE	NONE
Sand/Dirt	scalar	*Visual	NONE	NONE	NONE
Appearance	scalar	*Visual	NORML	NORML	NORML
Odor	scalar	*Visual	NORML	NORML	NORML
Emulsified Water	scalar	*Visual	>0.2	NEG	NEG
Free Water	scalar	*Visual		NEG	NEG

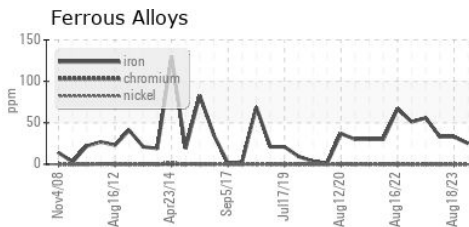
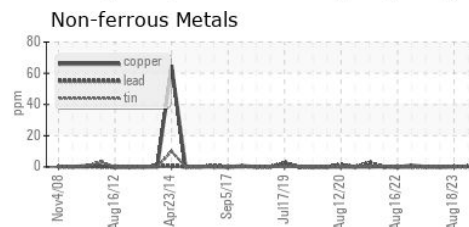
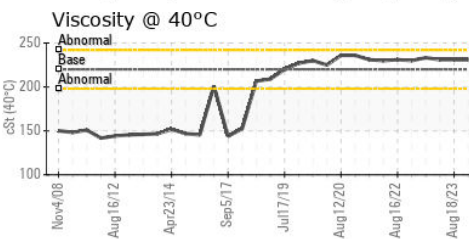
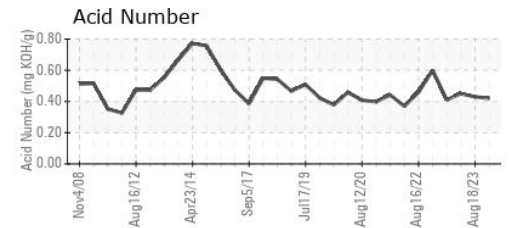
GRAPHS

All component wear rates are normal.

There is no indication of any contamination in the oil.

The AN level is acceptable for this fluid. The condition of the oil is suitable for further service.

Resample at the next service interval to monitor.
