OIL ANALYSIS REPORT

Area
AREA I [500313285]
 Machine Id
LIGHTNIN A1402 (S/N AD-15-19)
 Component
Gearbox
 Fluid
ROYAL PURPLE SYNFILM GT 220 (7 GAL)

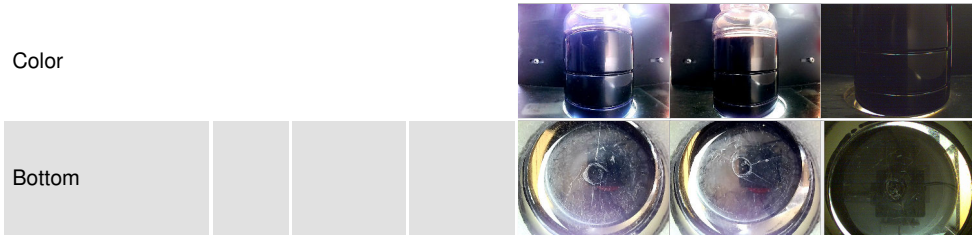
SAMPLE IMAGES	method	limit/base	current	history1	history2
---------------	--------	------------	---------	----------	----------

VISUAL	method	limit/base	current	history1	history2
White Metal	scalar	*Visual	NONE	NONE	NONE
Yellow Metal	scalar	*Visual	NONE	NONE	NONE
Precipitate	scalar	*Visual	NONE	NONE	NONE
Silt	scalar	*Visual	NONE	NONE	NONE
Debris	scalar	*Visual	NONE	NONE	NONE
Sand/Dirt	scalar	*Visual	NONE	NONE	NONE
Appearance	scalar	*Visual	NORML	NORML	NORML
Odor	scalar	*Visual	NORML	NORML	NORML
Emulsified Water	scalar	*Visual	>0.2	NEG	NEG
Free Water	scalar	*Visual		NEG	NEG

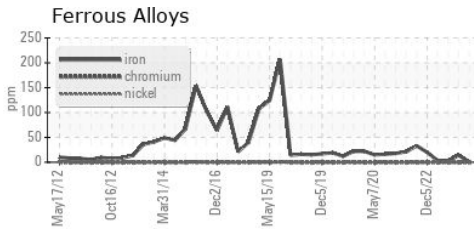
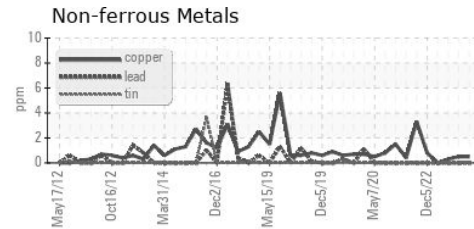
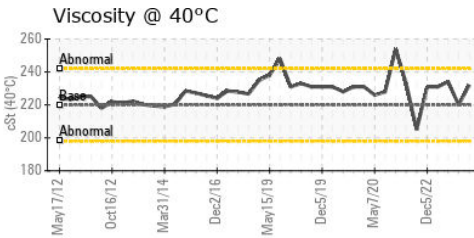
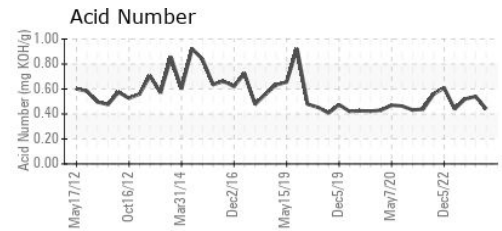
GRAPHS

All component wear rates are normal.

Resample at the next service interval to monitor.
